7. Building Damage

7.1 Damage of Reinforced Concrete Structures

S. Kono and H. Tanaka

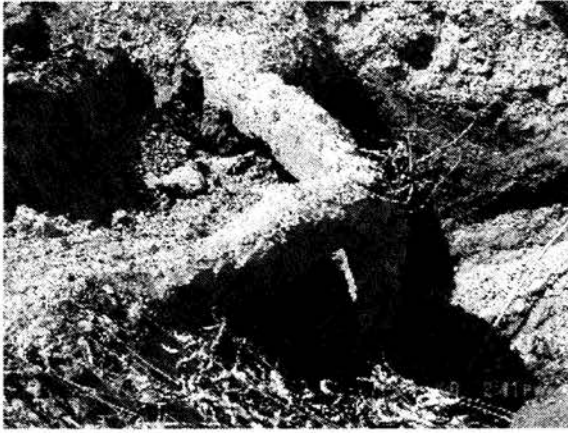
Most of the buildings that collapsed or suffered structural damage rested on shallow footings. Foundation depths are usually 1.5m for a five-story building and 2.0 - 2.7m for an eleven-story building as shown in Photo 7.3. Soil is alluvial and ponds have been filled to construct buildings at many places. Geotechnical investigations are not carried out as a basic engineering requirement. Tie beams are absent as the foundations were shallow. Buildings are designed only for gravity loads using 15MPa concrete for five-story buildings and 20MPa concrete for eleven story buildings (Goyal et al. 2001). The provisions of Indian Standard 1893 to calculate equivalent lateral loads for seismic conditions are not considered, and structural engineers are not even aware of the ductile detailing requirements of Indian Standard 13920. For example, the shear reinforcing hoops are arranged as shown in Figure 7.4. . For a ground floor column of 230 mm x 450 mm, common practice is to provide 6mm mild steel stirrups at a spacing of 200 mm in five-story buildings and in a 230 mm x 600 mm column, 8mm steel stirrups for eleven story buildings at a spacing of 200 mm (Goyal et al. 2001).

Photo 7.3. Foundation of collapsed five-story RC building.

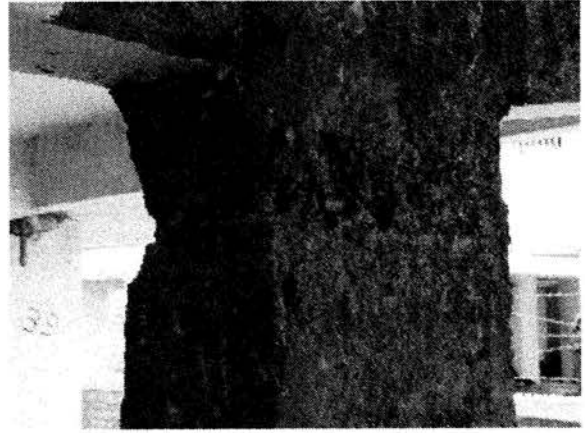
Photo 7.4. Honeycomb concrete can be seen above the construction joint.

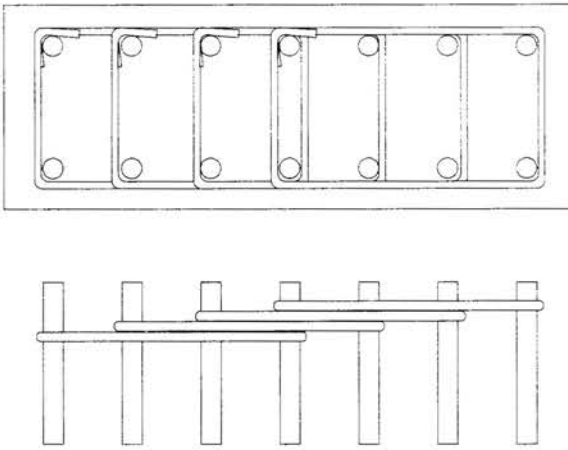
Figure 7.4. Spliced shear reinforcing hoops.

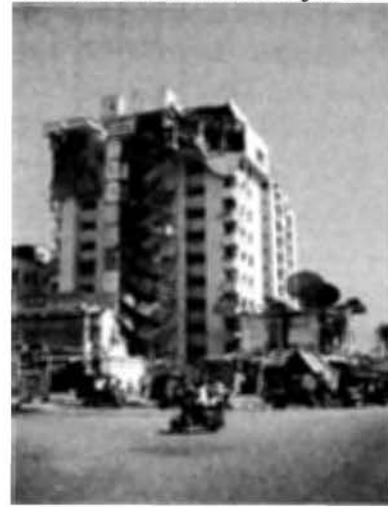
Photo 7.5. Mansi Complex collapsed because of the too much load from the pool at the top.

Extra floors and water tanks, added at the top of the building without strengthening the columns, further increased damage. For example, one of the most devastating failures of buildings was that of Mansi Complex constructed in 1994 in Photo 7.5, whose plan view is shown in Figure 7. 3. This eleven-story building had a soft ground floor with strong beams and weak columns. The half of the buildings split from the lift core and collapsed resulting in 46 casualties while the other half part in Photo 7.5. is still standing. Poor design practice, shallow foundations, and improper detailing caused the shear failure of columns at the ground floor. Additional loads of swimming pool and water tank without strengthening

the columns worsen the vulnerability. The half of the building did not collapse as the connecting beams and slabs failed due to improper embedment of reinforcement.

In some of the buildings, part of the building collapsed while stiff lift core block remained standing as there was no lateral load transfer mechanism to the core as shown in Photo 7.5. The slab reinforcement was not properly anchored to the beams or walls of the core. Failure of columns at the ground floor resulted in pulling out of the improperly placed slab reinforcement.

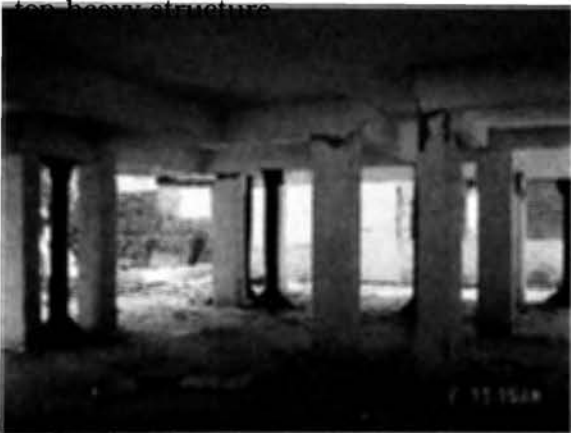
Photo 7.6. Columns are arranged in an irregular manner and the aspect ratio is large.

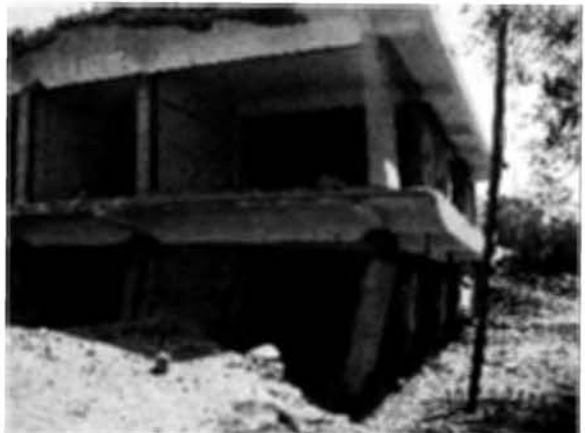
Photo 7.7. shows a commercial two-story RC building in Bhachau. All columns have large aspect ratio so that the inside can be fully utilized as a commercial space. In this type of columns, the anchoring of the beam reinforcement cannot be secured in a short distance of the weak axis direction and consequently ends of some beams completely pulled out from beam-column joints. The stiffness and strength in weak axis direction were not enough and the ground floor and the second floor swayed in the opposite direction. The complete pancake failure was avoided since some infill walls sustained the vertical load.

Photo 7.7. RC building in Bhachau collapsed in a side sway mechanism.

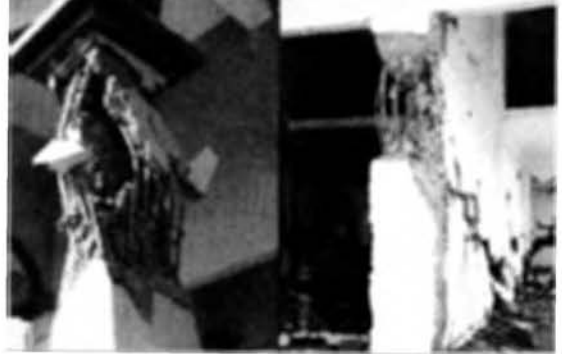
RC building named Pooja Flat in the city of Anjar. The ground and second floors were to be used for a commercial area and had large openings. As shown in Photo 7.9, damage concentrated on the lower floors with shear failure at the most ground floor columns which had shear reinforcement of $\phi 8$ at 200 mm pitch. The part of the structure beside the one in picture failed in a pancake manner and the other part behind lost the ground and second floors completely. These collapsed parts detached from the part in the picture because beams and slabs were not properly anchored to the standing block.

Photo 7.9. Shear failure of columns in Pooja Flat

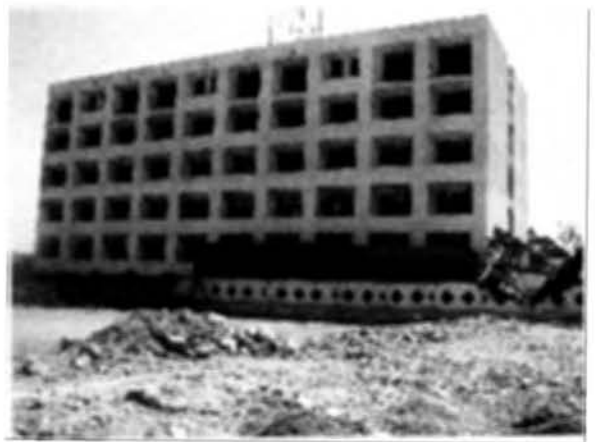
Sayaji hotel in Gandhidham shown in Photos 7.10, 7.11 lost its ground floor. The columns of the ground story had a section of large aspect ratio of 250x700 mm. The upper floor had 600 mm thick wall for an architectural reason. Those thick walls were made of solid brick and created an overload condition. The overload and the soft lower story lead to the failure.

Photo 7.10. Sayaji Hotel in Gandhidham failed at the soft ground story.

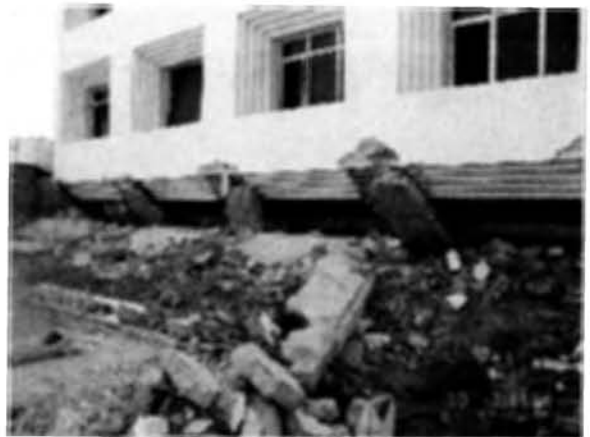
Photo 7.11. Columns with large aspect ratio failed at the ground floor at Sayaji Hotel in Gandhidham.

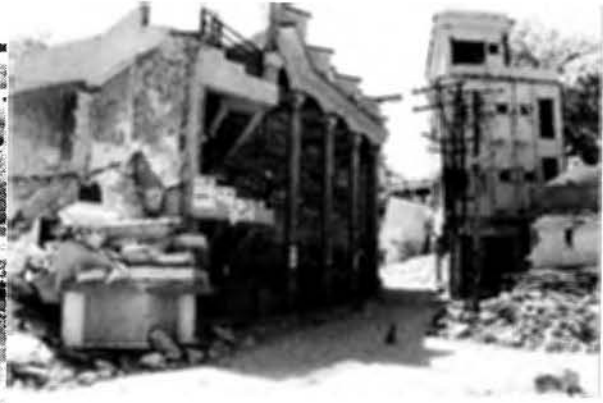
Photo 7.20 This partially damaged structure seemed to look very nice before the earthquake.

Photo 7.20 shows another case of a partially damaged structure. The back of the building, which collapsed, reveals the poor quality of the construction practice. This building seemed sound before the earthquake struck it.

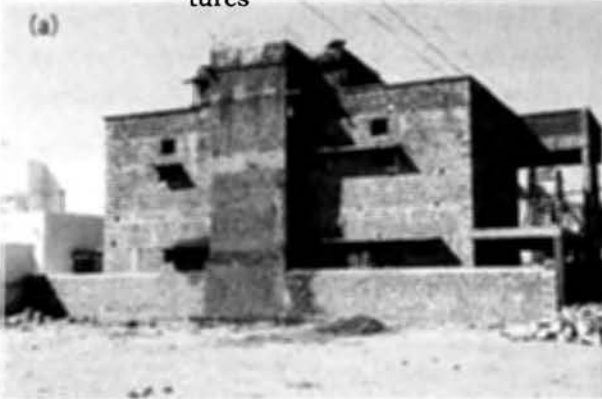
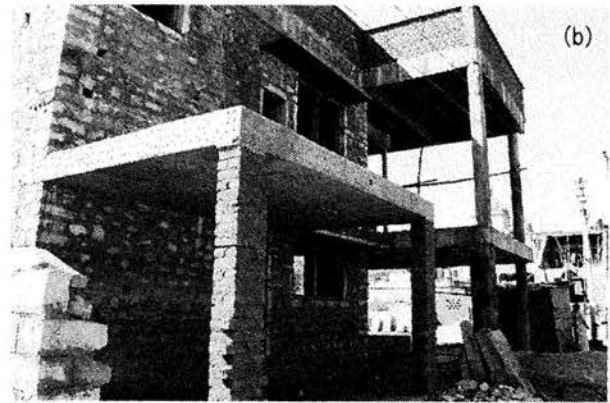
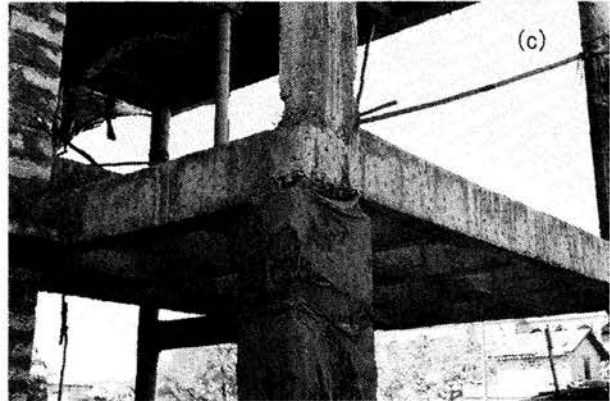
Photo 7.21 Two-story stone and brick masonry house with RC slab and lintel band

(b) The column supporting RC slab is made by just piling the bricks (Column in back side is RC)

(c) Close up of the RC column
(It is very slender and joint connection is poorly constructed.)

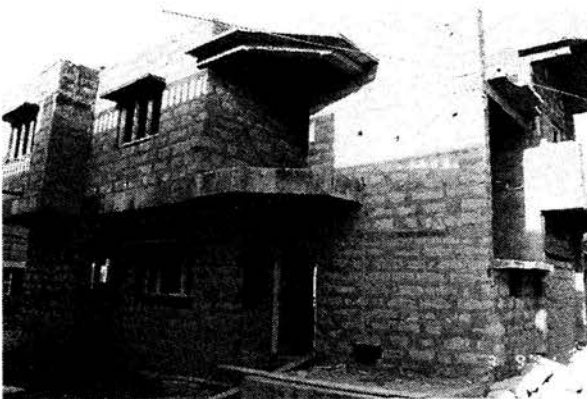
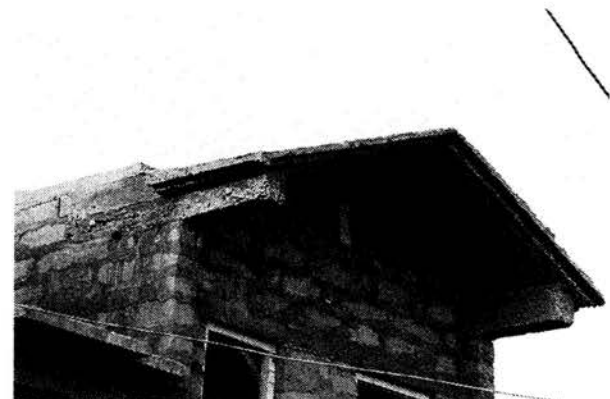
Photo 7.22 Huge stone masonry structure. Detail of a poor connection between RC beam and masonry wall, which might induce tension stresses on the wall

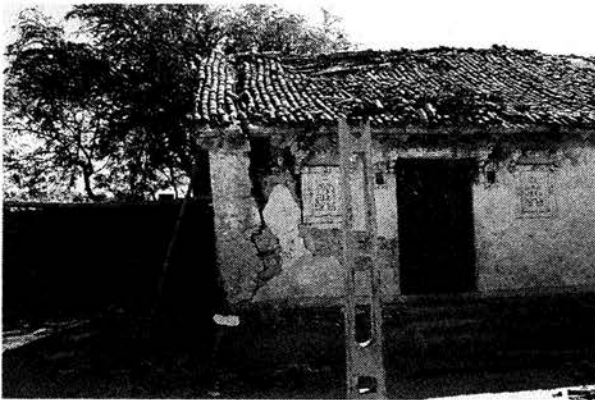
Photo 7.25 Separation of adjacent walls of a rectangular shaped dwelling

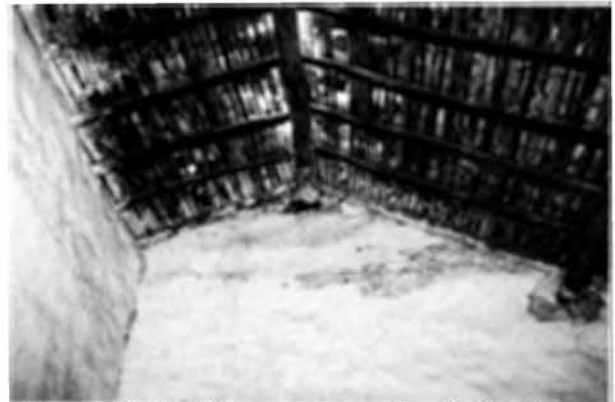
Photo 7.26 Roof damage caused by tile slipping

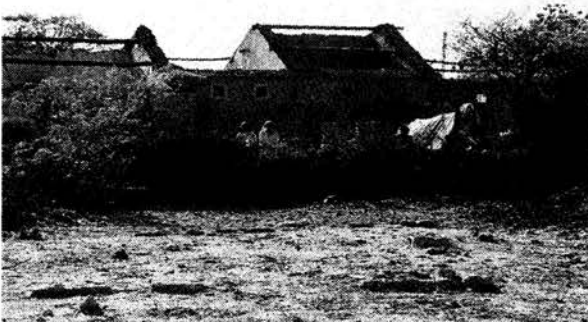
Photo 7.27 The roof collapsed and left the house unprotected

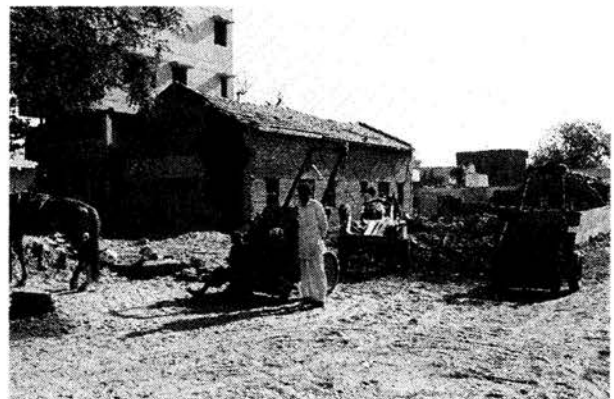
Photo 7.28 Separation of the adjacent walls of a single story masonry dwelling

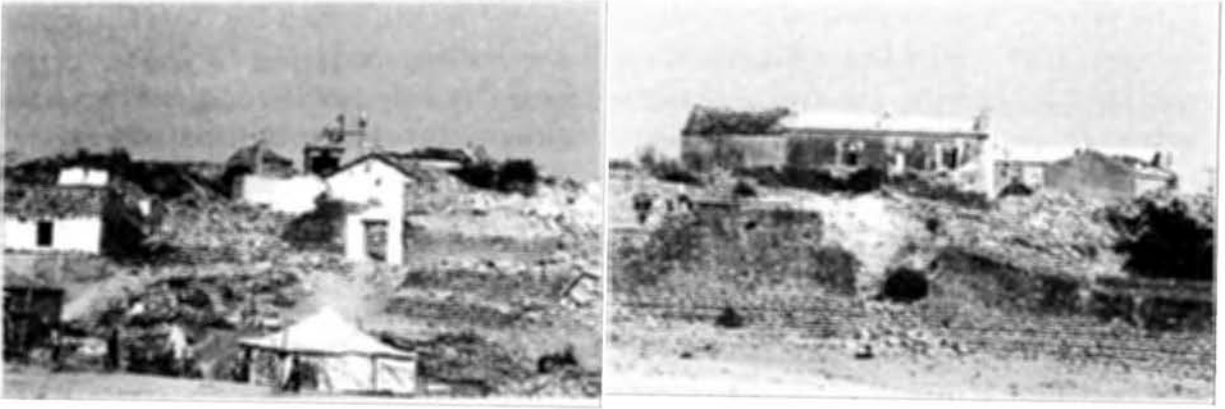
Photo 7.29 Topography induced local site effects caused extensive damage at this area located on top of a hill

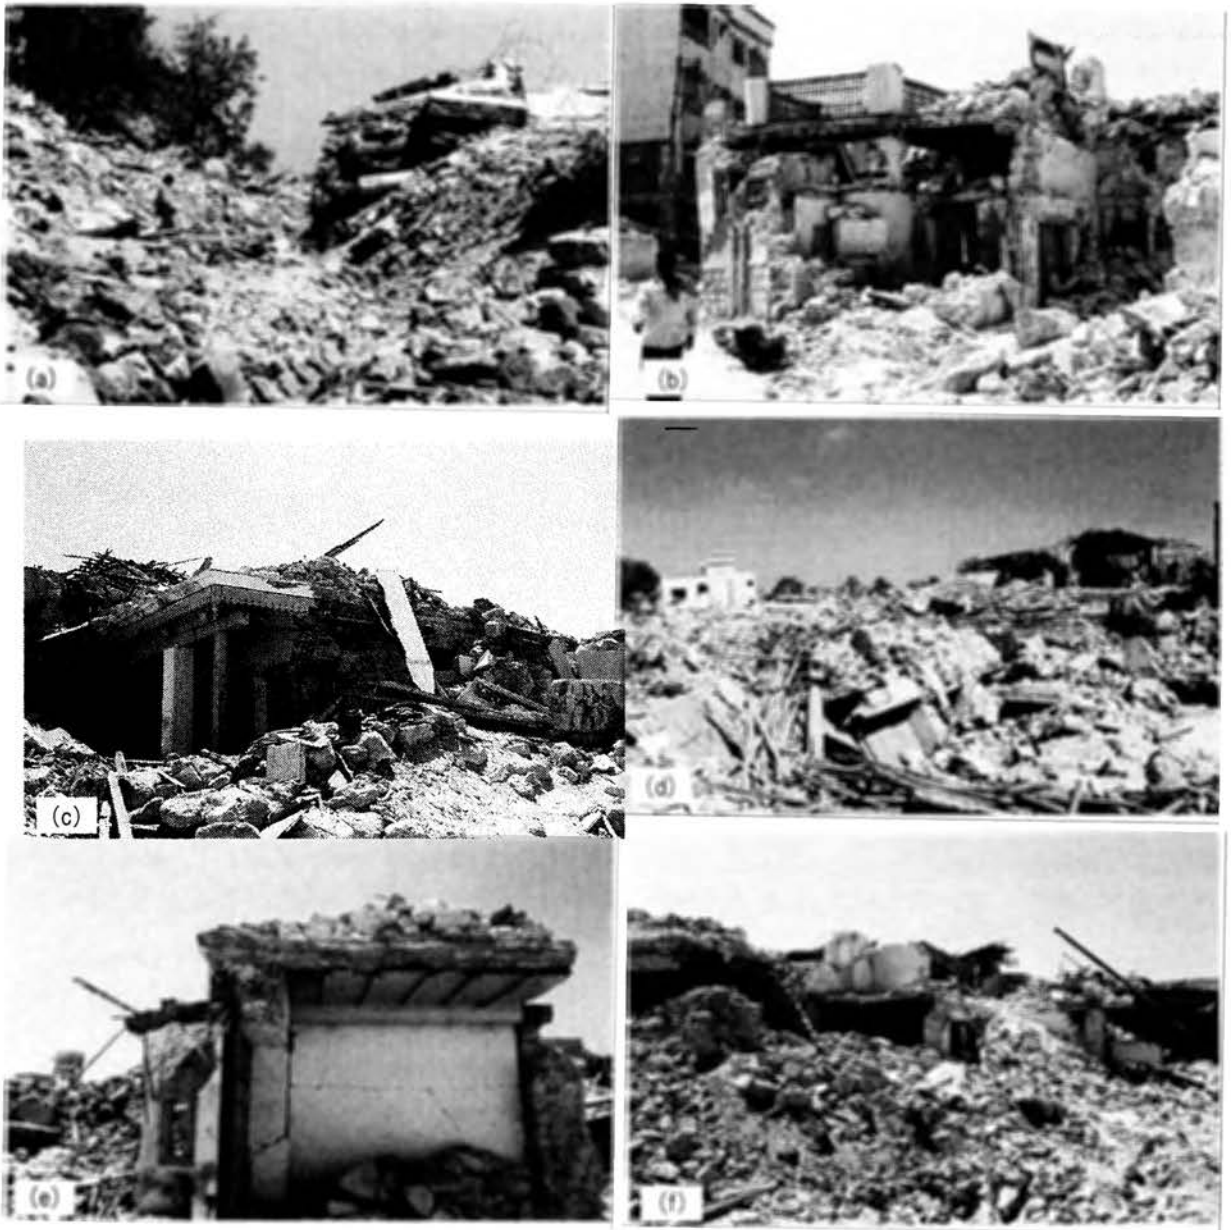
Photo 7.30 Towns where a large number of masonry houses collapsed

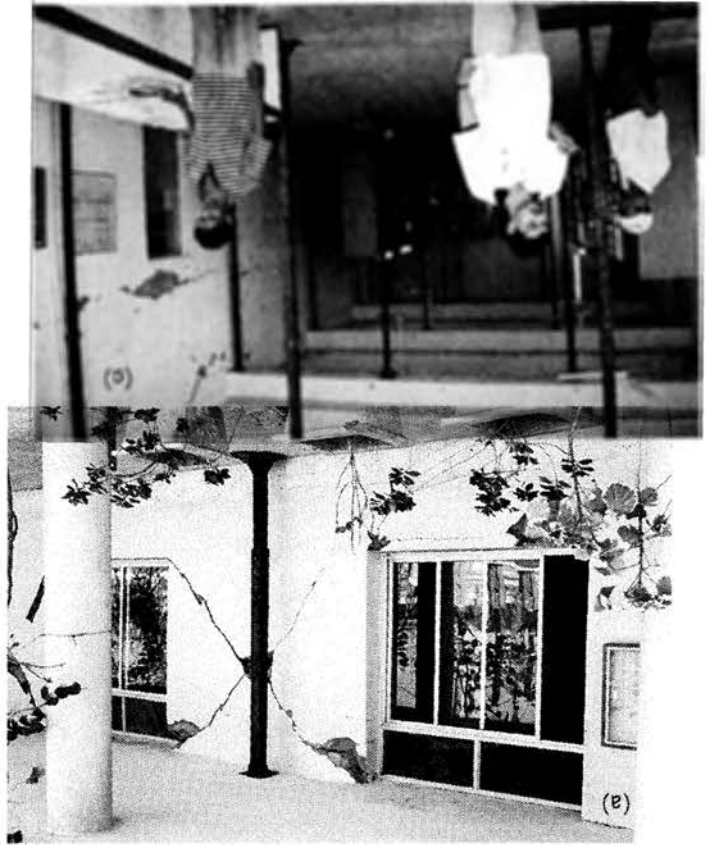
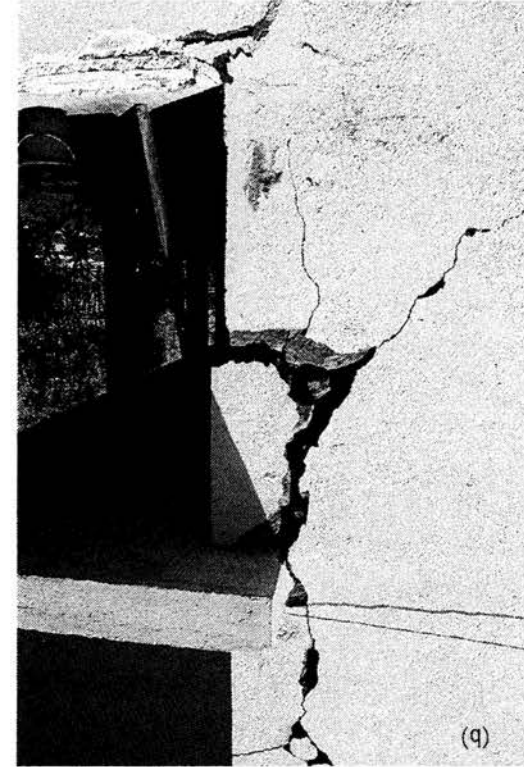
Photo 7.31 Damaged two-story RC frame houses with infill bricks (poor connection joints between column and beam, beam and wall, and column and wall)

- (a) Overview of the damage.
- (b) Column-beam joint.
- (c) ditto.

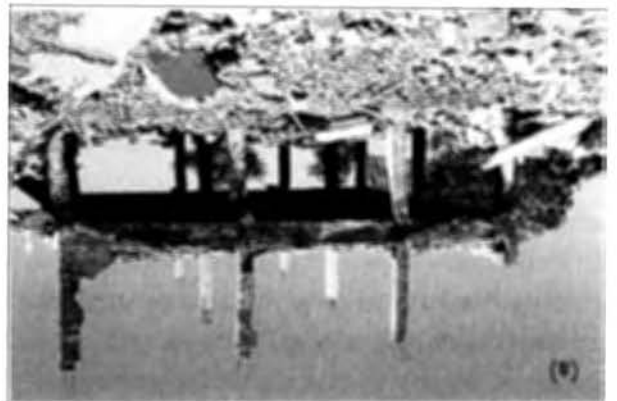
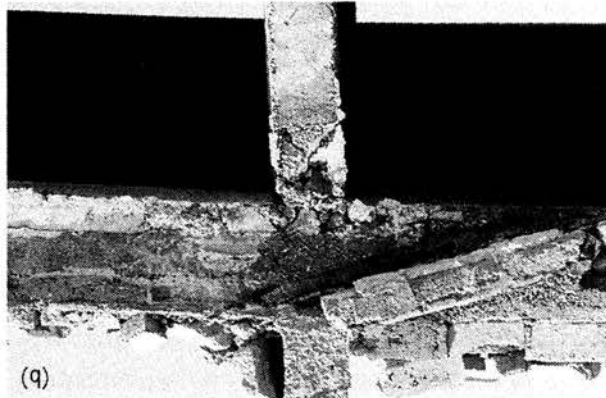
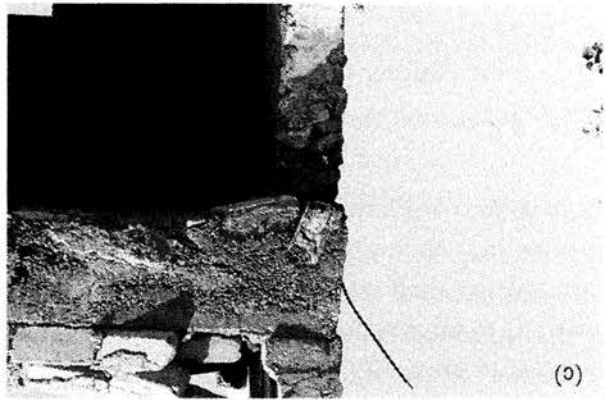
Photo 7.32 Damaged single-story masonry substation building

- (a) Overview of the damage.
- (b) No RC column can be seen at the corner of the structure
- (c) View of the structure interior, RC beams can be seen

Photo 7.32 presents a damaged substation facility whose main structure is masonry. An external roof and its supporting columns, both RC elements, are appended to it. Due to the lack of an appropriate connection between the slab and the masonry wall, the supporting wall was seriously damaged (Photo 7.32(c)). This

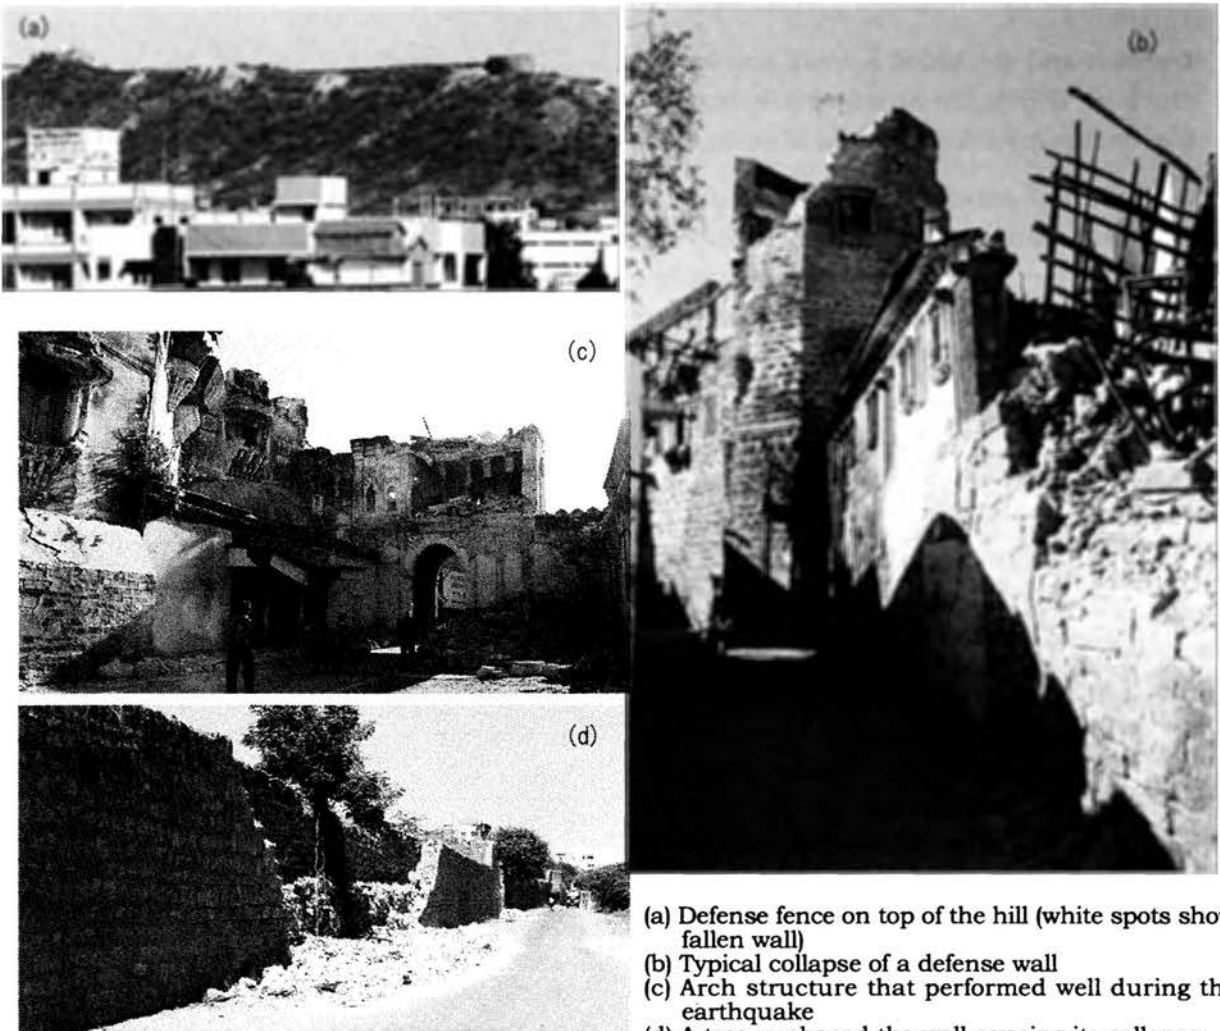
Photo 7.34 Walls and fences

Photo 7.34(d) shows the effect of a tree on the performance of a masonry wall. The roots of the tree growing on top of the wall pen-

(a) Defense fence on top of the hill (white spots show fallen wall)
(b) Typical collapse of a defense wall
(c) Arch structure that performed well during the earthquake
(d) A tree weakened the wall causing its collapse

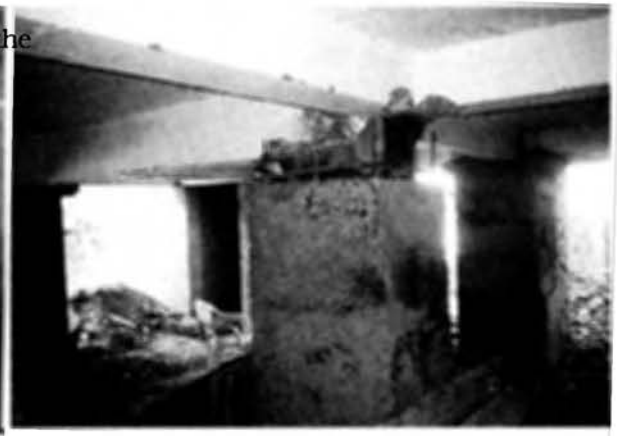
Photo 7.44 The connection between the reinforcement of the column of first story and the floor-beam of the second story was inadequate, leading to weak beam-column joint.
