8. Damage to Civil Structures and Liquefaction

M. Hamada, O. Aydan and J. Kiyono

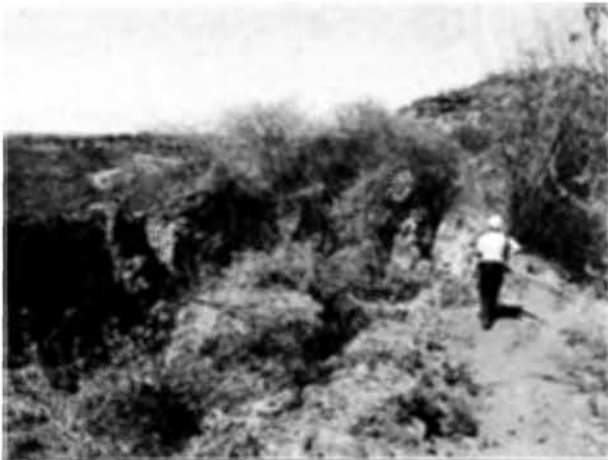
Most of the dams are earthen dams except a few, which is stone masonry, built. The dams are built for irrigation purposes. There are more than 174 earth dams in the region. Seven medium sized dams and 14 small sized dams in Kutch were damaged. The major dams, which were damaged during the earthquake, were Chang, Tapar, Suvi, Shiviakha, Kaswati and Rudramata dams. Most of the dams failed or damaged at their old river course sections. The reason

of the failure or damage was associated with the liquefaction of sub-soil below the embankment of the dam. Photo 8.1 shows views of damage to Suvi and Chang dams.

(a) Chang Dam

Photo 8.1. Views of Failures

Although the base rock of the Chang dam was mudstone with almost horizontal layering, the old river course may be consisted of sandy material. In the upstream side the sand boiling can be clearly observed even more than 50 days passed over the earthquake (Photo 8.13(a)). It seems that the

failure of the dam is due to liquefaction at its base and it resembles to the failure of San Fernandes dam. Furthermore, some lateral spreading could be observed at many locations around the reservoir (Photo 8.13(b)).

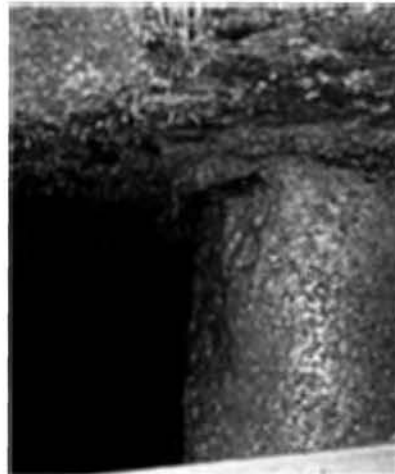
(a) chipped pile head

Photo 8.2. Cracking of piles at Kandla port

Berths No.1 to 5 at Kandla Port have developed some major structural damage. Berths No.6 to 9 are functional. The strong shaking damaged many piles supporting the docks of berths No.1 to No.5. The piles were cracked by the bending, and some concrete pieces were chipped from the pile tops. The pile length is about 20m below the frame structure and the diameter is 60cm. The cracks on the piles are not severe as shown in Photo 8.2. However, they have to be repaired with the steel plate or carbon fiber jacketing in order to protect the steel bars from the corrosion.

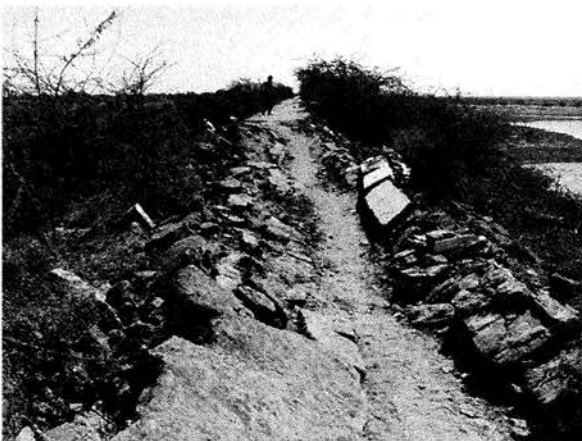
(b) Suvi Dam

Some lateral spreading of ground was observed within the Suvi dam reservoir. This may be due to soil liquefaction as quartzitic sand with a repose angle of 32 degree is observed along the cracks. The slumped section of this dam was also thought to be the result of liquefaction of soil at the base of the dam.

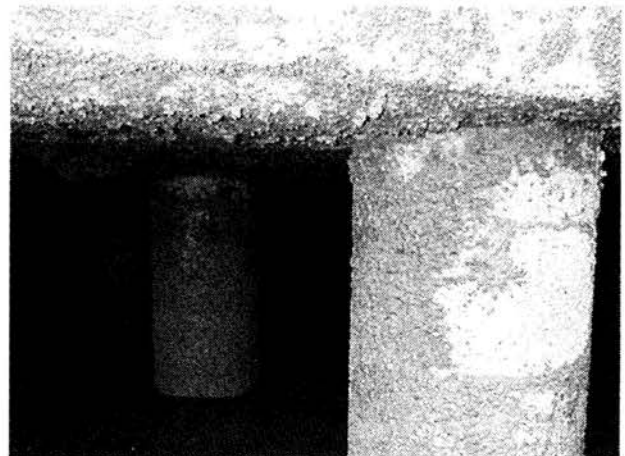
(a) hair cracks on the pile surface

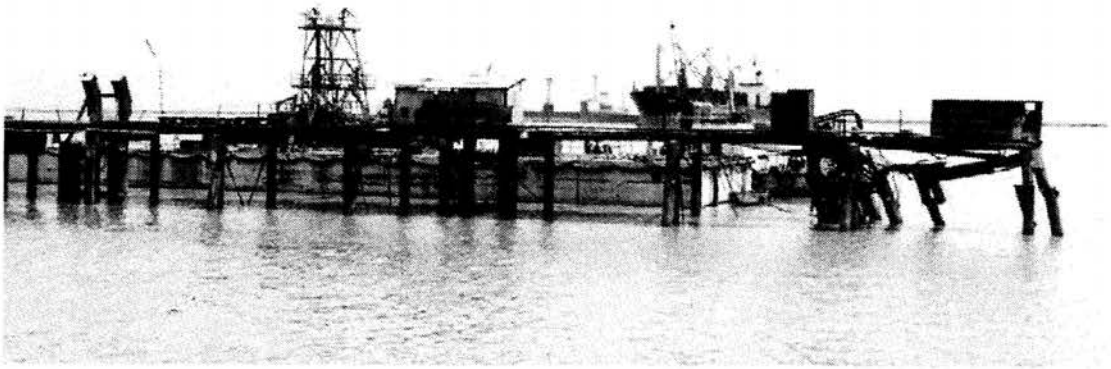
Photo 8.3. A view of damaged oil jetty at the Kandla port on March 19, 2001.

The old jetty of the port on the piles with a length of 15m is shifted towards the sea. The top of piles had small hair cracks. Furthermore, the settlement of filled section of the port was about 7cm. The jetty of the oil-pipelines at Kandla port was heavily damaged due to breakage of the piers (Photo 8.3). The piers were almost ruptured at their mid.

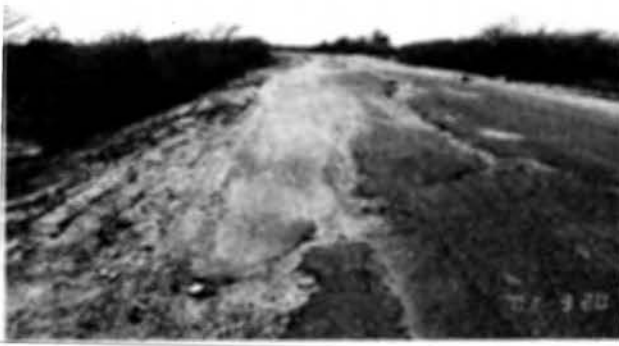
(a) Bachau-Bhuj roadway

Photo 8.4. Damaged roadways due to ground deformation

Out of 650km of highways, 100km severely damaged. Most of roadways had to be re-surfaced due to extensional and bulging type cracking (Photo 8.4). In some places, the traffic had to be diverted for the repairment of embankments. The tollgate buildings of the highway 8A were broken at their base columns (Photo 8.5). Furthermore, the embankments of bridges settled and caused the slow down of the traffic (Photo 8.5).

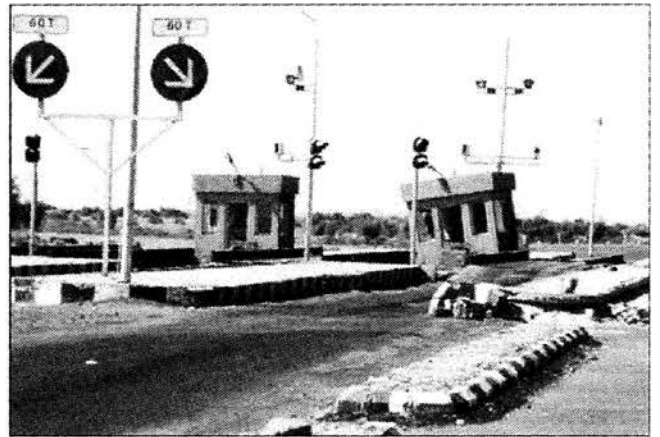
(a) toll gates

Photo 8.5. Damage to toll gates and settlement of bridge embankments

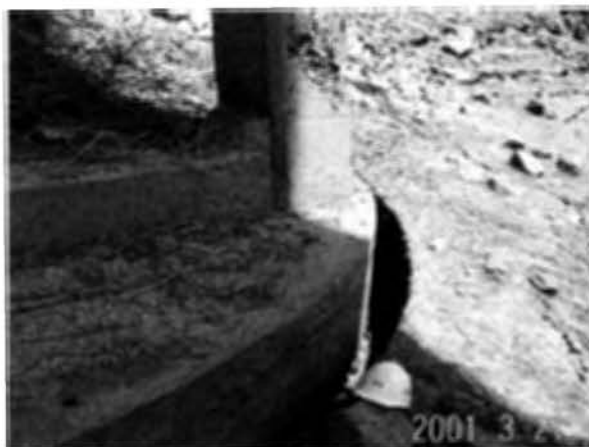
Photo 8.6. Gap between foundation and surrounding soil at Rudramata bridge

Most of the minor/major roadway and highway bridges in Kutch region were damaged. Parapets of the minor and major bridges were totally or partially toppled or displaced in the entire region affected by the earthquake. The settlement and lateral spreading of ground particularly affected the piers of Hadakia Bridge and Rudramata Bridge (Photo 8.6). The soil at both sides of the bridge abutments settled and spread

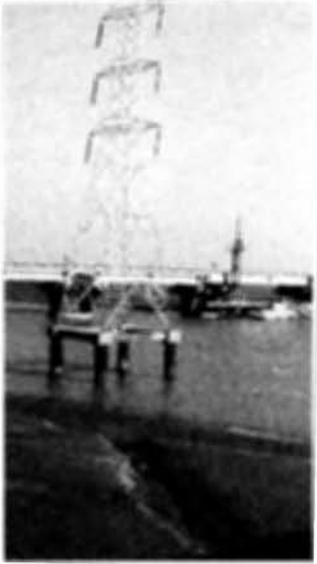
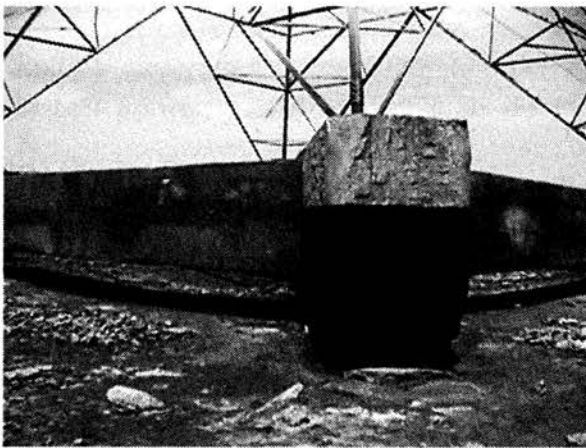
Photo 8.7. Damaged pylons near Hadakia Bridge

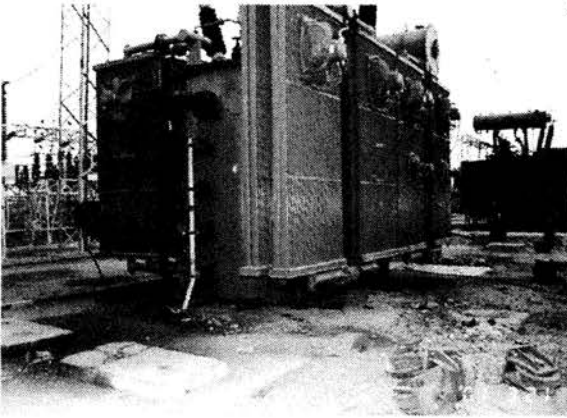
(a) derailed transformer

Photo 8.8. Damaged transformers and breakers at Anjar substation

In the Anjar 220kV substation, the communications system and power protection system had failed when the battery rack collapsed. They could not enter the control building because of concerns about collapse of the roof. The unanchored control panels inside did not topple. In the yard, all transformers derailed, some bushings broke (Photo 8.8). Four circuit breakers had failed porcelain insulators (Photo 8.8). The first major substation was brought back online on 1/29 in Bhuj (132 kV), and the first 220 kV substation brought back on line in Anjar on 1/30. As of 2/5, an estimated 80% of the region's power had been restored.

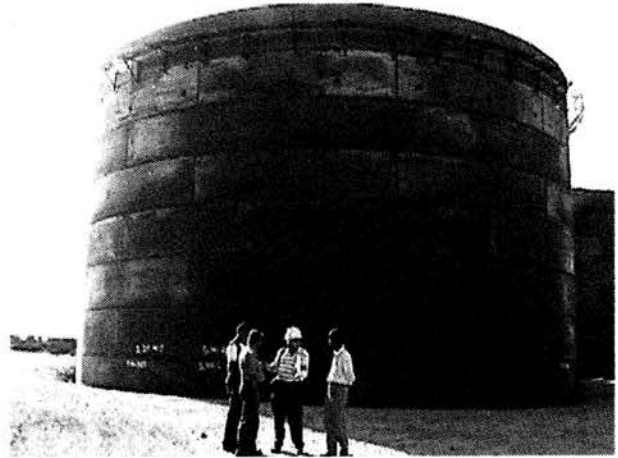
(a) tilted tank

Photo 8.9. Tilted and damaged tanks at the Friends Tank Farm

Two tanks were heavily tilted and connections of valves to pipelines were

damaged due to tilting and sinking of the tanks (Photo 8.9). It seems that the tilting and sinking were due to foundation failure associated with the base soil. Considering the bulging and motion of the ground, it seems that the ground moved in the direction of S40W-S50W. Besides the two heavily tilted tanks, some differential settlements, tilting and sinking of the tanks were observed in the newly reclaimed tank yard. In oil tank yard, which was built for more than 20 years ago, the settlement of the ground was not observed.

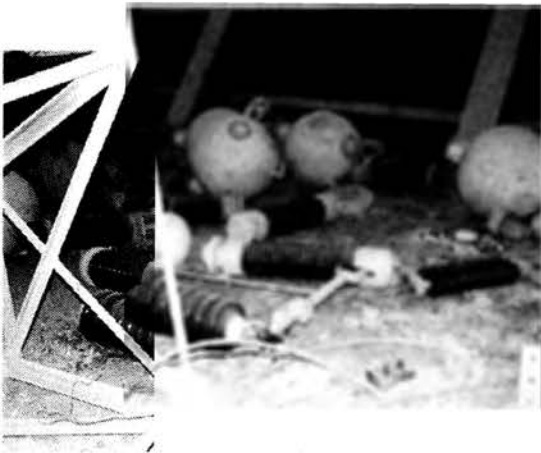
(b) damaged circuit breaker

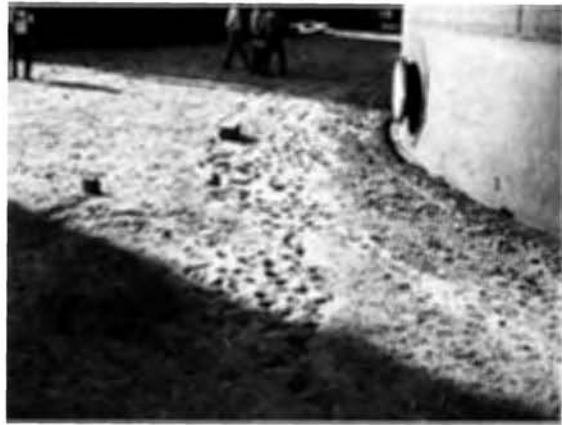
(b) damaged tank

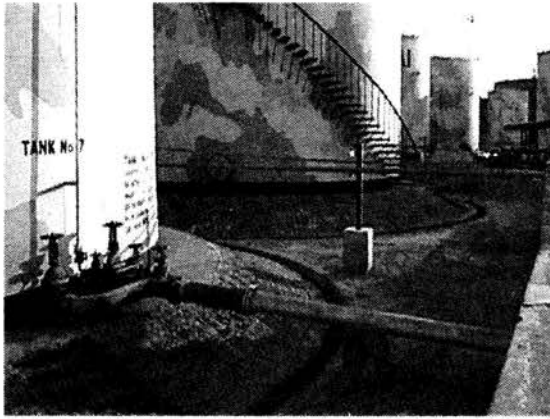
Photo 8.10. Damaged Tanks at Oil India

Most of tanks were non-damaged in the Tank farm of Oil India (Photo 8.10). Nevertheless, some oil tanks were buckled or tilted. Some of damage to tanks was due to the liquefaction of the foundation soil. There were 6 steel tanks with a conical fixed roof. No damage to tanks was observed although it was very close to the epicenter of the earthquake. The tanks had 2m thick concrete basement. The buildings in this complex, however, were heavily damaged. One of storehouses was completely collapsed while the roofs of other storehouses were partially collapsed.

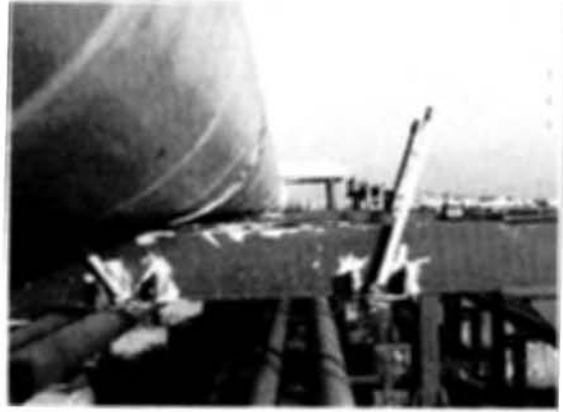
(a) broken fixtures

Photo 8.11. Damage to pipelines

type fixtures were either broken or separated from their welding locations (Photo 8.11(a)). The pipes were displaced both laterally 30cm and longitudinally 40cm. The direction of movement was NE towards the epicenter. The liquefaction and lateral movement of the ground was observed at the base of pipelines as shown in Photo 8.11(b). Crude oil pipelines from Salaya, feeding Koyali/Mathura/Panipat refineries resumed operations since 27th Jan after due checking. The oil pipelines from the Kandla

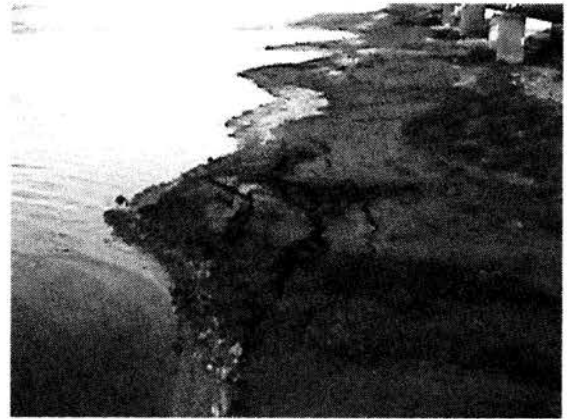
(b) liquefaction at pipeline base

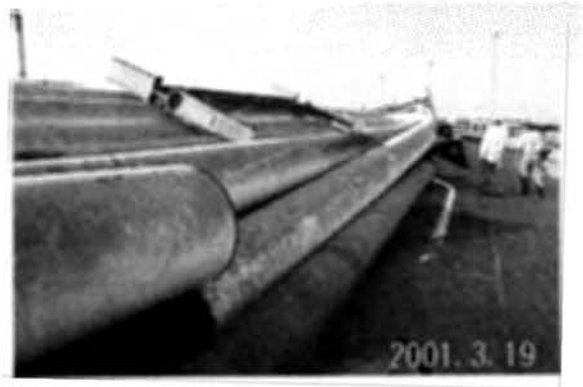
(c) damaged pipelines with collapsed steel frame

Port were severely damaged (Photo 8.11(c)). The pipelines are supported by the two layer steel frames and each frame supports three pipelines. Two of them were filled with oil during earthquake. The pipelines are running to the NS direction and the south ends are curved to the west direction. Because the ground motion of the NS direction was dominant and the shaking modes were different for the three parallel pipelines, which have different curvatures, the steel frames were buckled and collapsed with the pipelines.

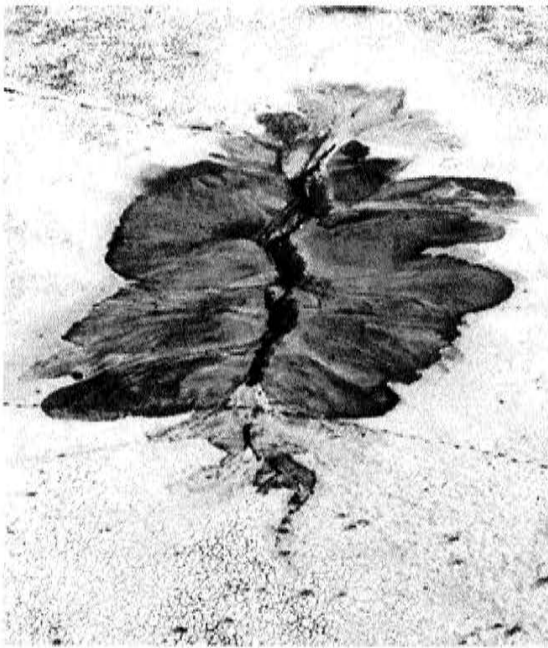
(a) Dhori

Photo 8.12. Some examples of liquefaction

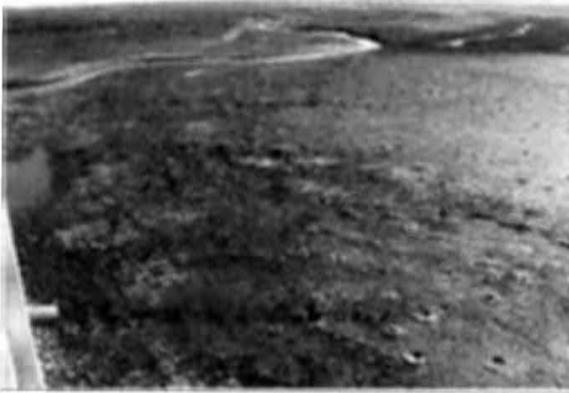
(b) Hadakia Bridge

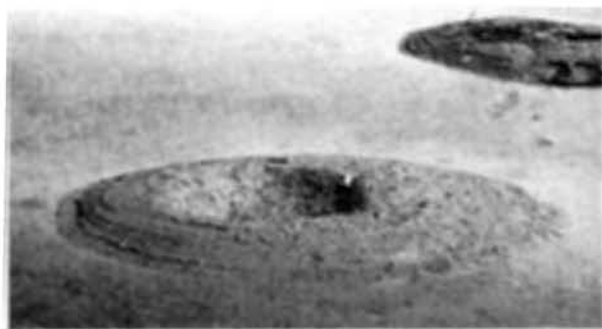
(a) sand boiling

Photo 8.13. Liquefaction and lateral spreading at Chang dam

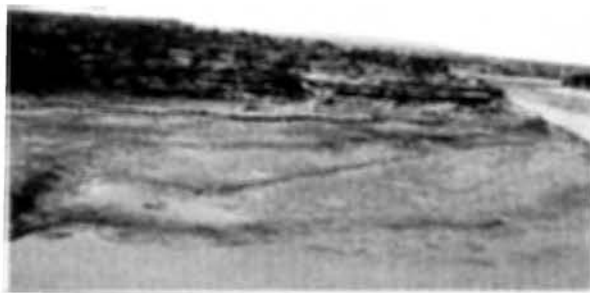
(a) wide spread lateral spreading

Photo 8.14. Settlement and lateral spreading in the vicinity of Rudramata Bridge

Wide spread lateral spreading of ground was observed at both sides of the valley of the Rudramata Bridge as shown in Photo 8.14(a). The soil at both sides of the settled and spread towards the center of the valley.

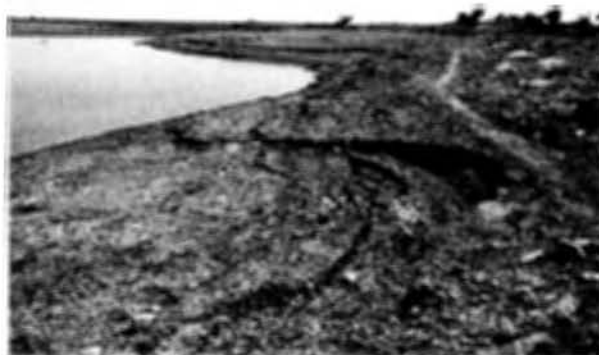
(b) lateral spreading around reservoir

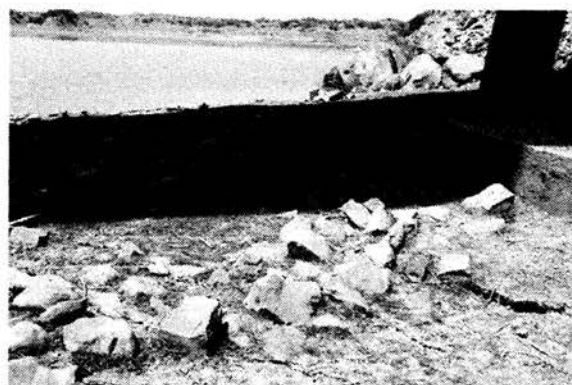
(b) crack due to lateral spreading

Cracks run along the longitudinal axis of the valley. The crack on the south embankment was mistakenly interpreted as the fault break. The crack is due to the lateral spreading of the ground (Photo 8.14(b)).

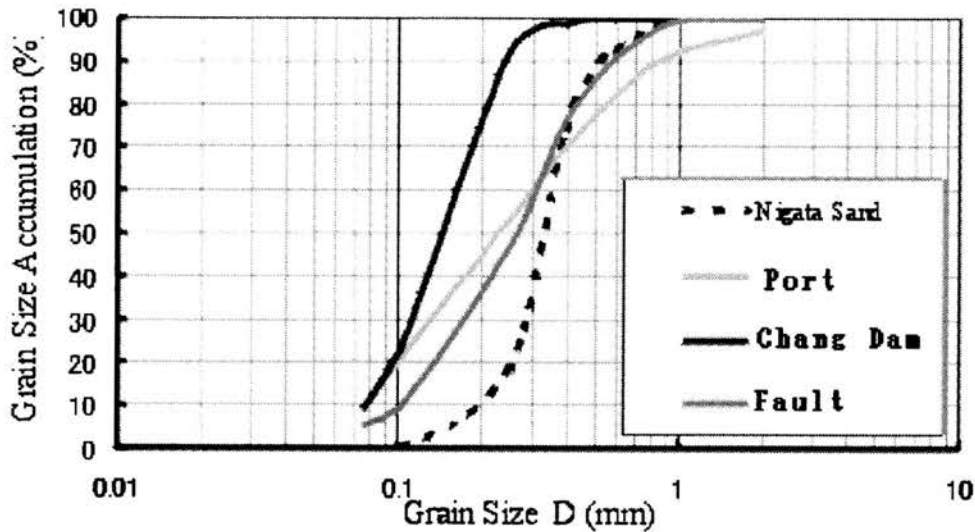
Figure 8.1. Grain size accumulation of the boiled-out sands

Figure 8.1 shows the grain size accumulation curve of the boiled-out sands at Kandla port, Chang dam and Chobari with the sand from Niigata City. The samples mostly consisted of liquefiable fine sands with mean grain sizes of 0.15 ~ 0.30mm, respectively.

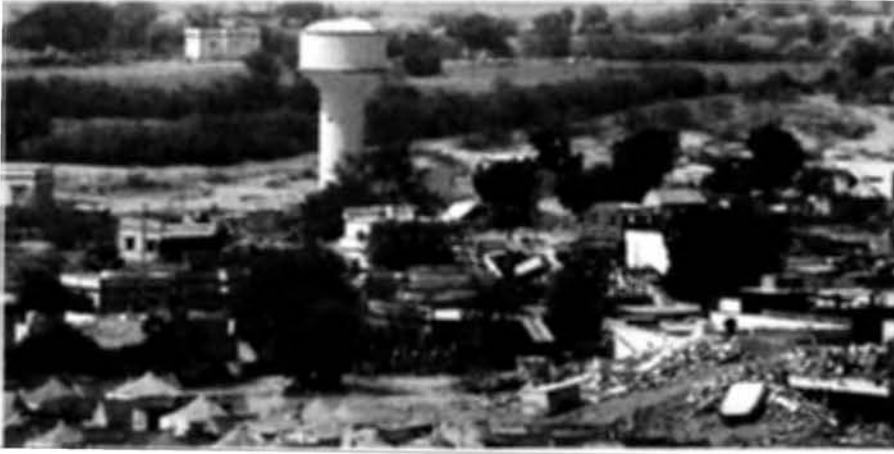
Many of the systems have elevated concrete storage tanks that are on the order of 30m high (Photo 8.15). Most of the water tanks, which are elevated, did not suffer any substantial damage although severe damage could be observed at nearby buildings and structures. The water tank at Chobari village was toppled (Photo 8.16). The water tower was fallen in the direction of S30E. The location is 23° 31' 22"N;70° 20' 64"E. The water tank in Bachau town also survived the earthquake. The water tank in Anjar was an RC structure with four piers and built in 1955 with a capacity of 20000

Photo 8.15. Non-damaged typical elevated water tank in Bachau

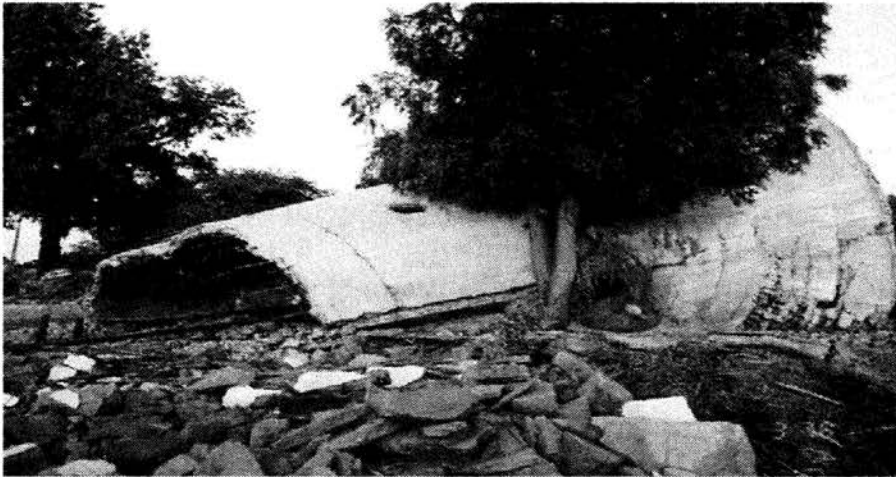
Photo 8.16. Collapsed water tank in Chobari village
