## 6. Estimation of Macroseismic Intensity

### 6.1 Macroseismic Intensity deduced from the Building Damage

Y. Hisada and K. Meguro

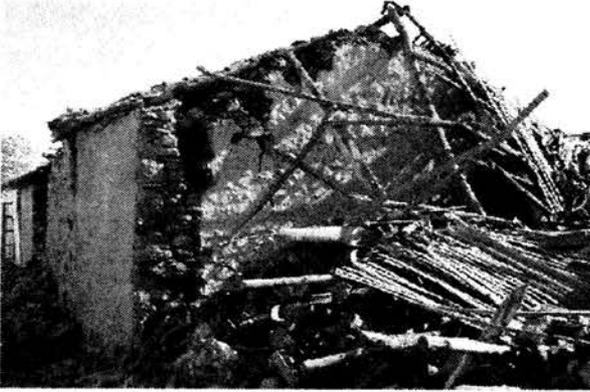
Photo 6.1. Type 1 masonry house (Class A)

We classified the vulnerability of the buildings in Gujarat as follows (see Fig.6.2). First, the masonry houses are classified into Type 1 to 3. **Type 1** represents typical traditional houses, which are made of rubble stones with mud mortar and wooden roofs (see Photo 6.1). This type is

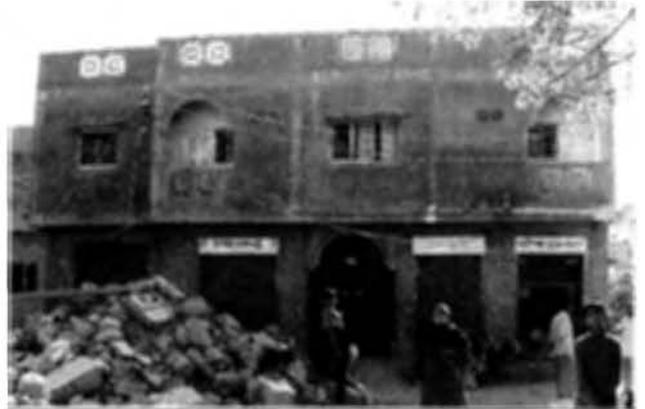
Photo 6.4. RC building without piloti (Class C)

On the other hand, typical **RC buildings** in Gujarat are made of RC frames with un-reinforced concrete blocks. Since the earthquake resistant design code is not mandatory in India, they are classified as vulnerability Class C (see Fig. 6.2). However, during the survey, we found that the damage grades were clearly different between buildings with and without pilotis (see Photo 6.4 and 6.5). RC buildings with pilotis were found extremely weak, i.e.

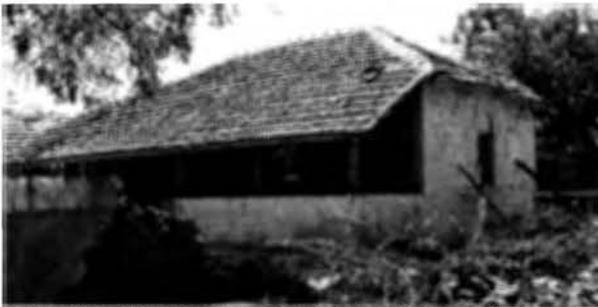
Photo 6.2. Type 2 masonry house (Class B)

categorized as vulnerability Class A. **Type 2** represents relatively new houses, which are made of simple stones or manufactured blocks with wooden roofs (see Photo 6.2), and are classified as vulnerability Class B (Fig.6.2). **Type 3** are newer houses, whose walls are similar to type 2, but have RC roofs and/or RC floors (see Photo 6.3). They are classified as vulnerability Class C (Fig.6.2).

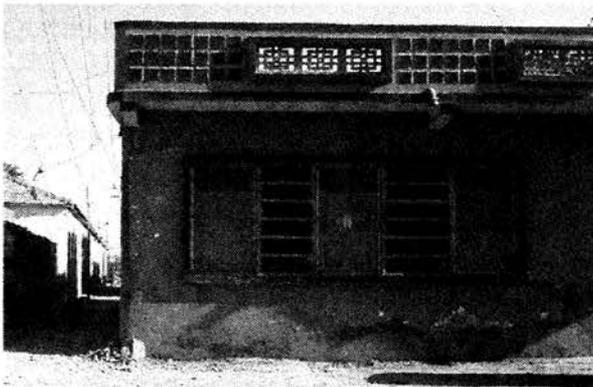
Photo 6.3. Type 3 masonry house (Class C)

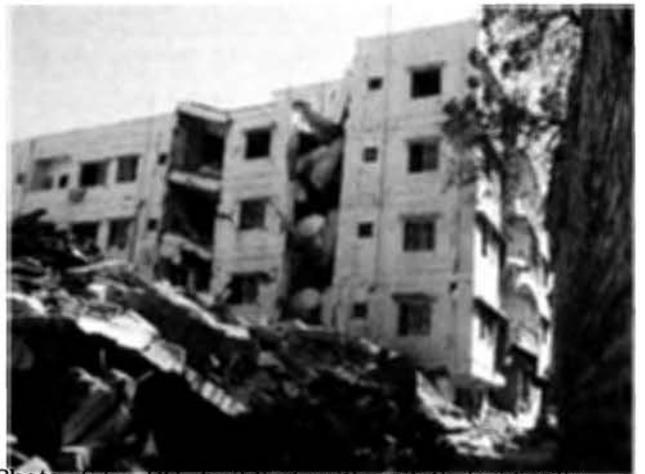
Photo 6.5. RC building with piloti (originally classified as Class C, but in reality weaker than Class C)

equivalent to Classes A to B. Actually, almost all damage in Ahmedabad was concentrated on the buildings with piloti. Therefore, we take into account these effects when we estimate macroseismic intensity.

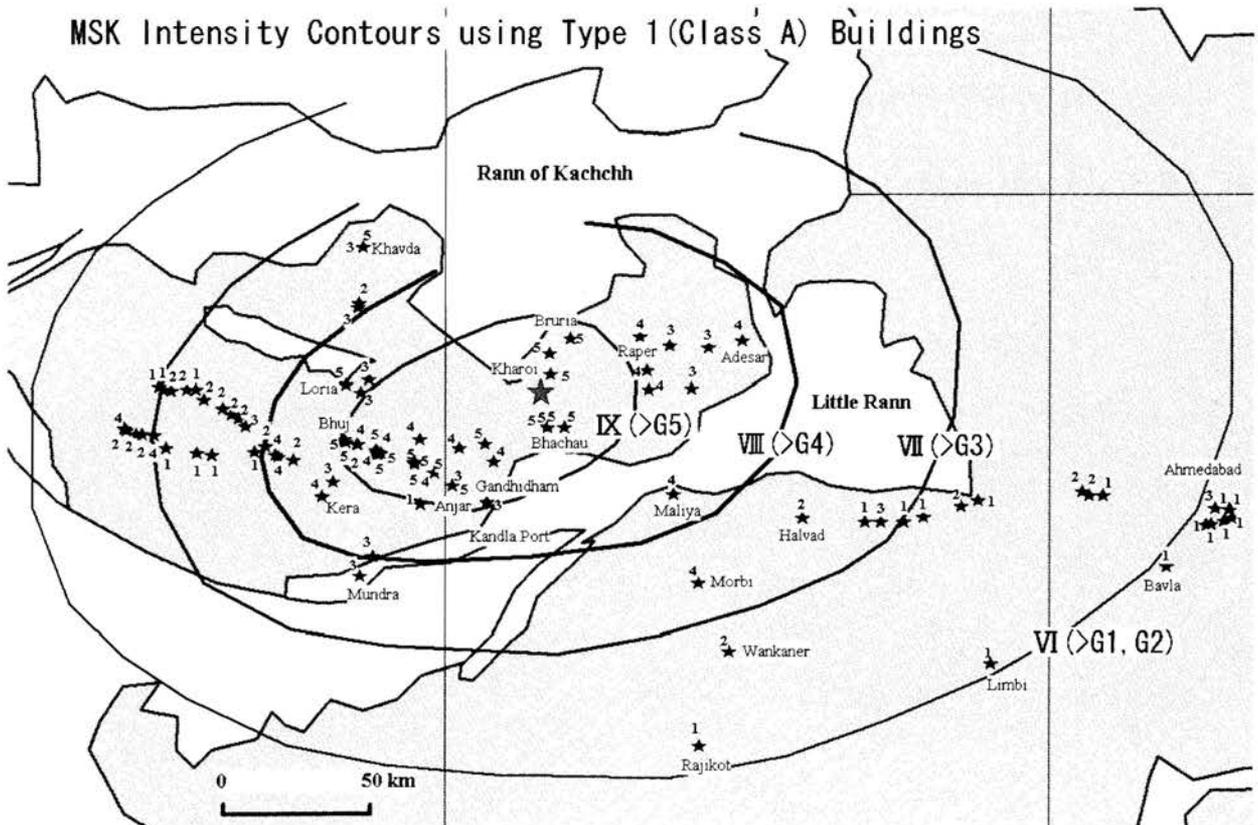
Fig 6.5. MSK intensity contours using the damage data of Type 1 buildings

Fig.6.5 shows the estimated intensity contours using only the damage data of buildings Type 1 (Class A). Although we see some differences in grade in the same villages between different groups, the

villages/cities with the highest damages (G5) are concentrated around the epicentral area, and the areas with smaller grades scatter

into circumferences. In Figs. 6.5 to 6.8, we used thicker lines in the contours with higher grades because they are probably

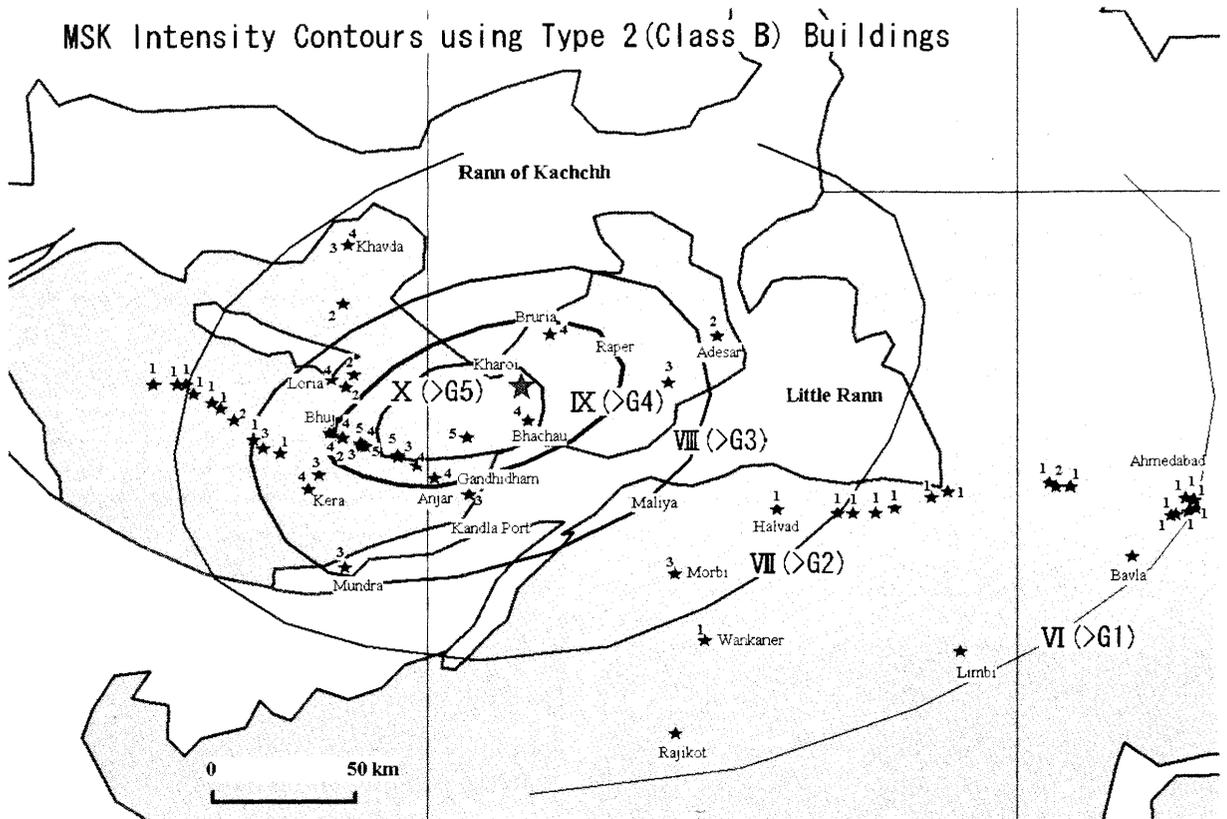
Fig 6.6. MSK intensity contours using the damage data of Type 2 buildings

more reliable; damage grades G4 and G5 are easily detected visually, but this is not the case of G1 and G2. Similarly, Figs. 6.6, 6.7, and 6.8 show the estimated intensity contours using only the Type 2 (Class B), Type 3 (Class C), and RC (Class C or less for structures with piloti) data, respectively. The similarity of contours suggests the overall reliability of the data. Finally, Fig.6.9 shows the integrated intensity contours using all the data from Figs. 6.5 to 6.8.

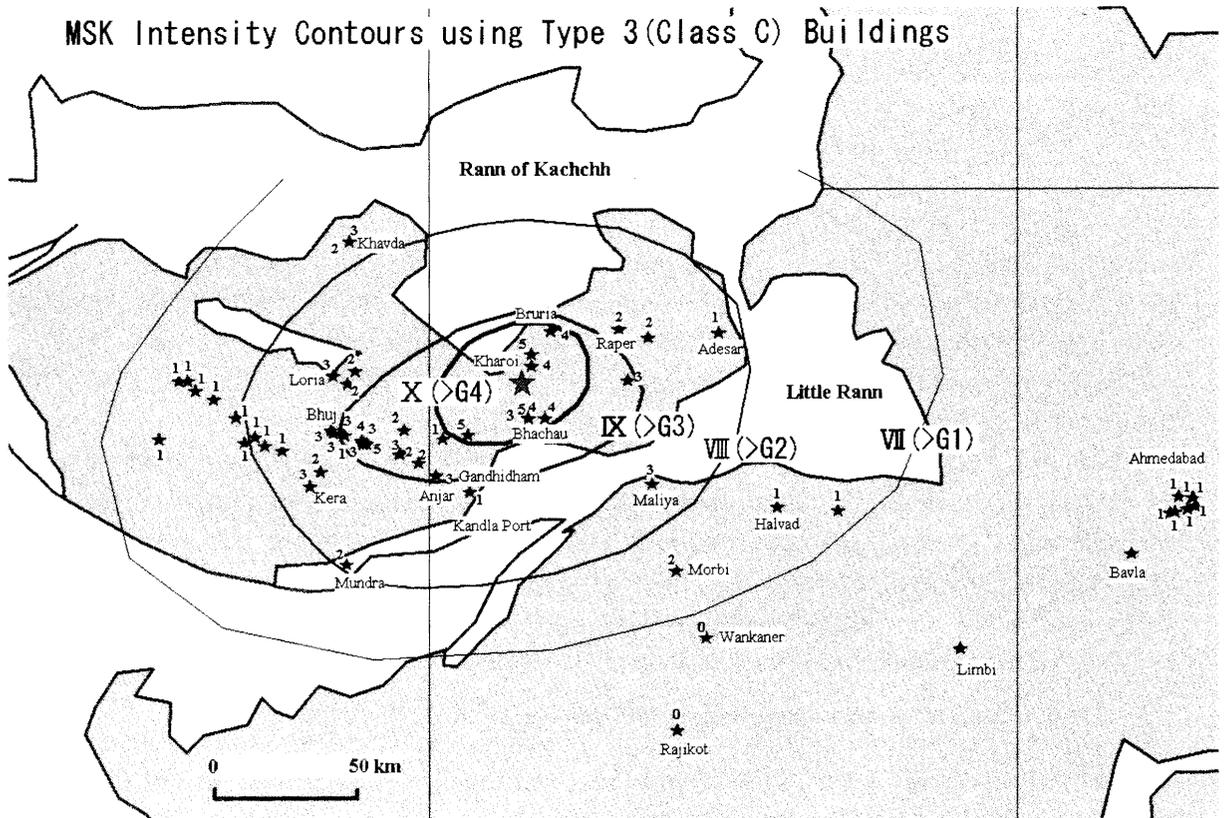
Fig 6.7. MSK intensity contours using the damage data of Type 3 buildings

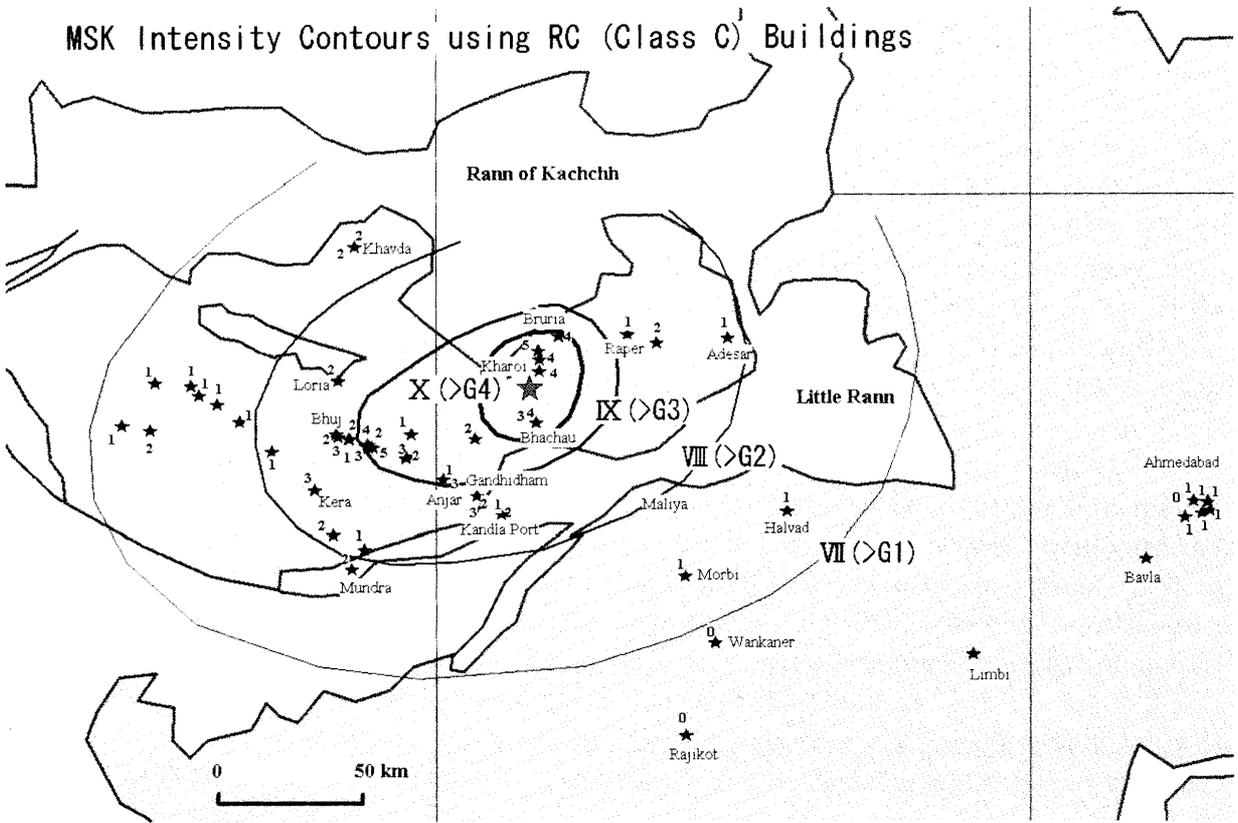
Fig 6.8. MSK intensity contours using the damage data of RC buildings

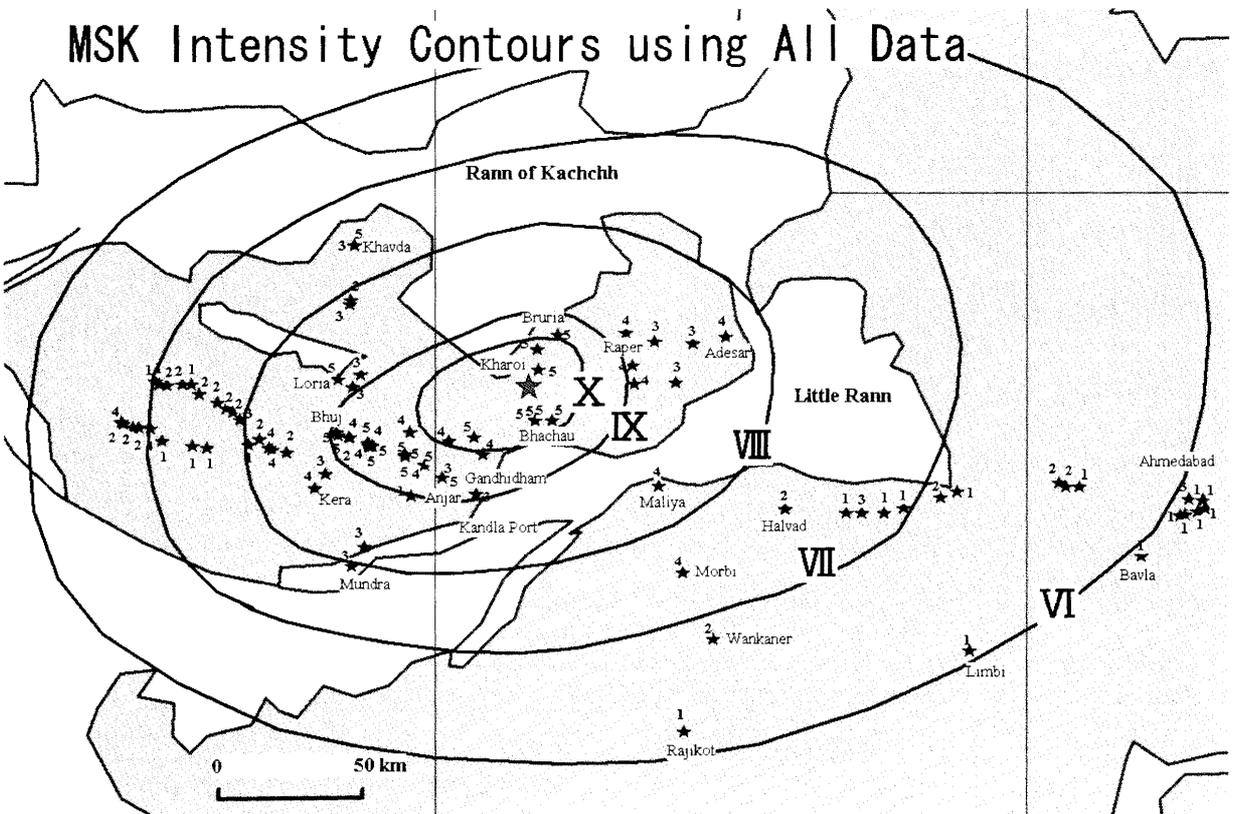
Fig 6.9. MSK intensity contours using all the data

We shall compare our intensity map shown in Fig.6.9 with the other existing intensity maps. Fig.10 shows a MM intensity map by Martin and Hough (2001), which was estimated using media information. Although there are similarities between both maps, there are also distinctive differences. In particular, the map of Martin and Hough (2001) shows the highest intensity around Bhuj, rather than around the epicentral area. This is probably because of media

where  $S_5$  is the area with intensity larger than JMA intensity 5. In our proposed intensity map (Fig. 6.9), the area corresponding to JMA intensity 5 or higher is about 21,500 km<sup>2</sup>. Thus, we obtain  $M \approx 7.5$ , which is close to  $M_w = 7.6$  reported by

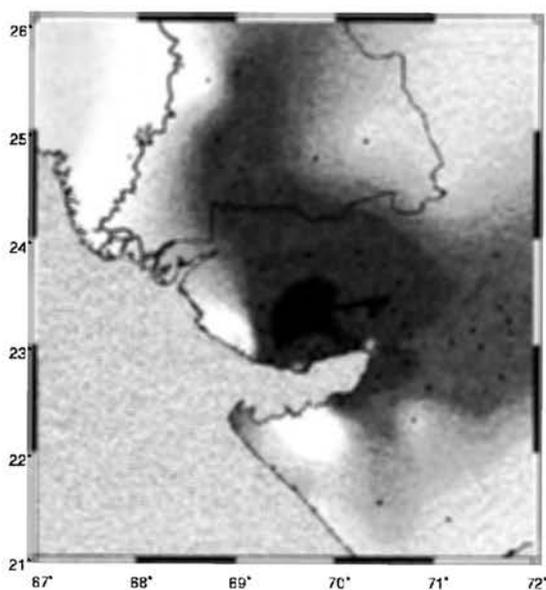
Fig 6.10. MM intensity using media data (Martin and Hough, 2001),

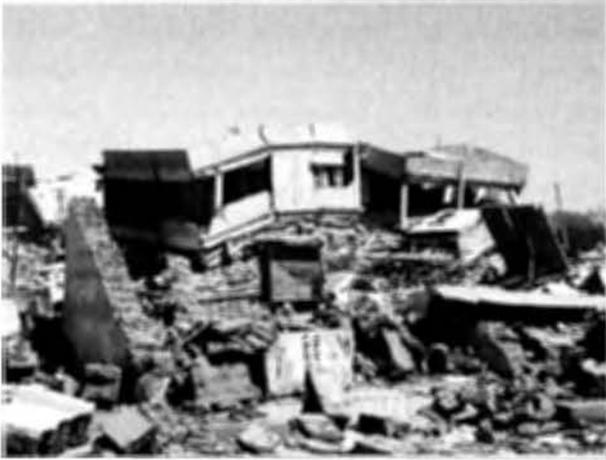
Photo 6.6. Damage to a RC building in Bhachau

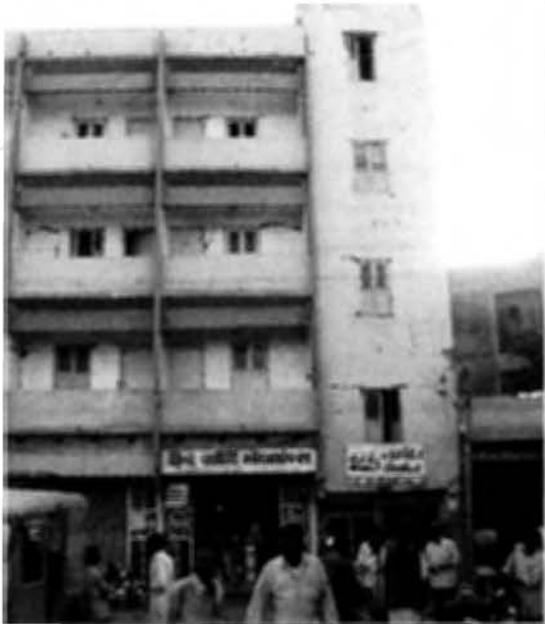
Photo 6.7. Damage to a RC building in Raper

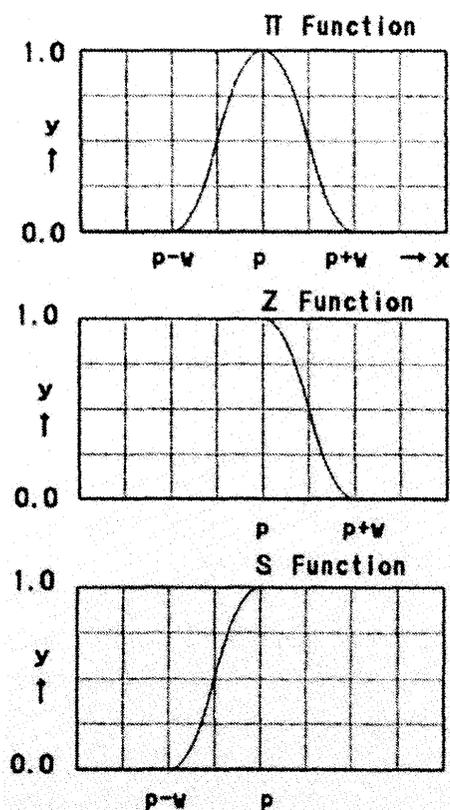
Figure 6.13. Schematic diagram showing the three types of membership functions, Pai, Z and S.

The authors developed questionnaire method to estimate seismic intensity based on Modified Mercalli Intensity Scale of 12 levels and applied to some earthquakes in California and in the 1988 Nepal-India border region (Murakami et al., 1991). The questionnaire items of 34 questions and categories were edited based upon the definition of MM and MSK intensity scales. For each item category, corresponding seismic intensity was given. Fuzzy set theory was applied to the seismic intensity coefficient, because, likelihood of intensity suggested by each item category have some sort of fuzziness and not exact indicator. Membership function for fuzzy function were prepared for each item category as in Table 2 and Figure 13. As a membership function, Z functions are given for the smallest category for each question item, Pai functions are given for the intermediate categories, and S functions for the largest categories (Fig. 1).

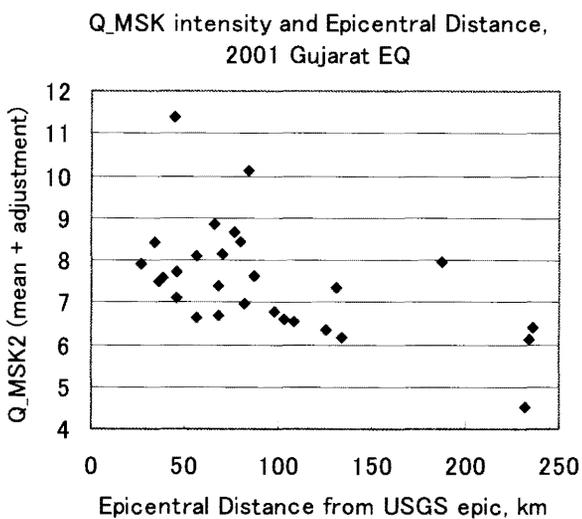
Figure 6.15. Estimated intensity ( $Q\_MSK2$ ) vs. epicentral distance.

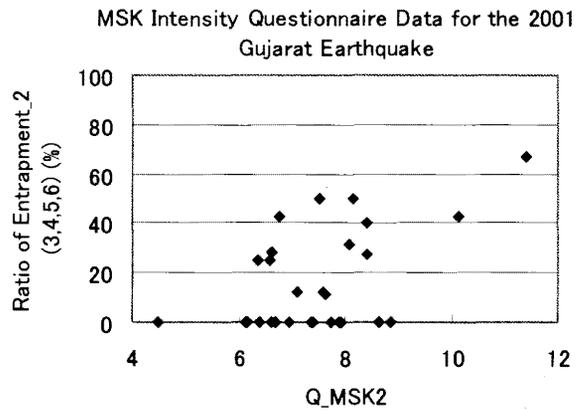
Figure 6.16. Ratio of entrapment and estimated intensity ( $Q\_MSK2$ ).

Figure 6.16 indicates the relation of ratio of entrapment ( $Q$ uestion 21) and seismic intensity estimated. Again the scattering is still very large and further examination of intensity estimation method is necessary.

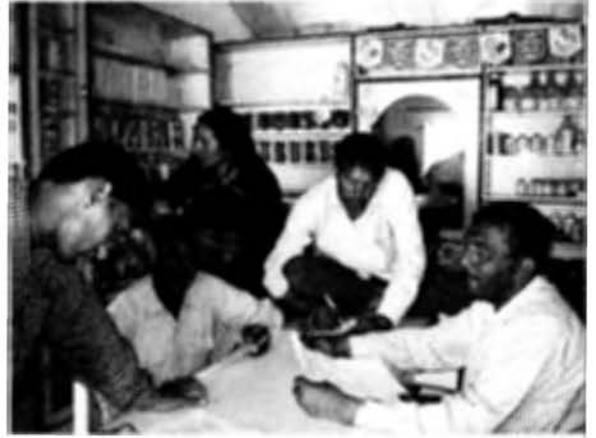
Photo 6.9. Intensity questionnaire survey in Dhaneti.

MSK seismic intensity survey was conducted by use of the questionnaire method and intensity was estimated based on modified method by Shiono and Koyama (2000). Types of dominant vulnerability classes in each location, that corresponds to building types, were considered and intensity estimation was modified. Using the estimated MSK intensity, seismic intensity distribution were depicted in the macro seismic zoning map and the relation of intensity to the epicentral distance were examined. The cause of scattering in intensity estimation will be reexamined further to reach more reliable intensity estimation.

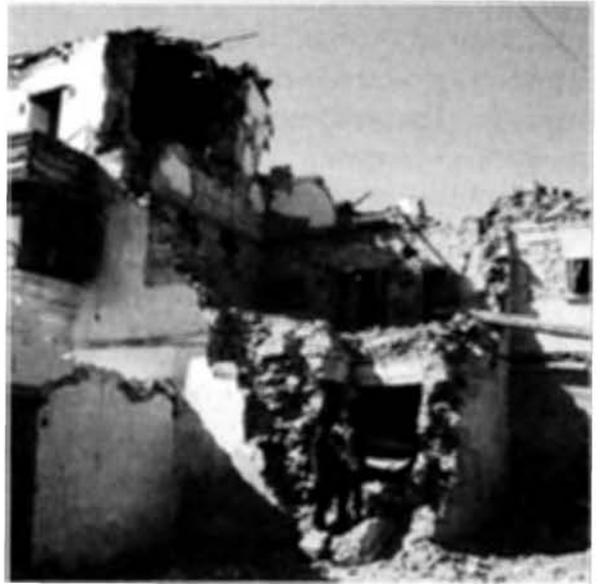
Photo 6.10. Damage in Adeser,  $Q_{MSK2}=8.2$ .

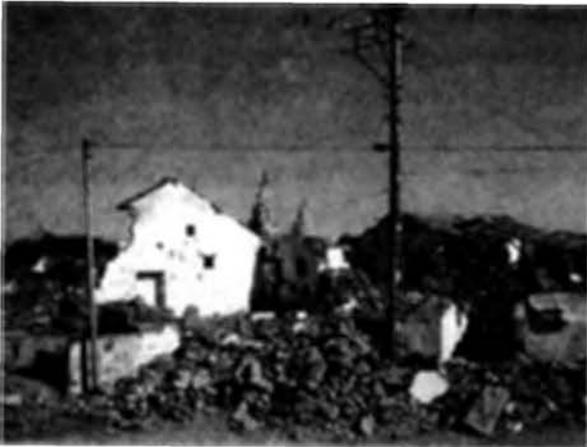
Photo 6.8. Damage of masonry dwellings in Loria,  $Q_{MSK2}=8.9$ .

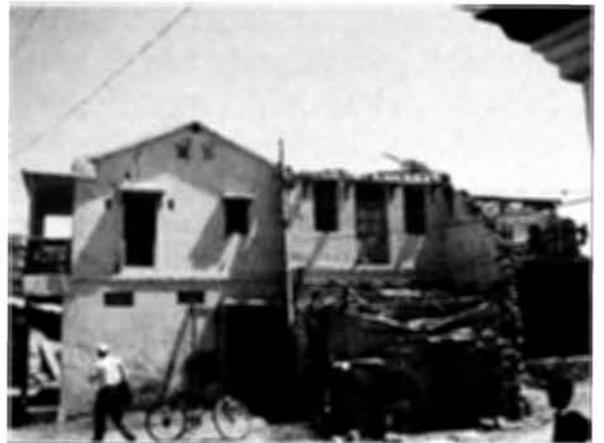
Photo 6.11. Damage of masonry building in Mundra,  $Q_{MSK2}=7.6$ .

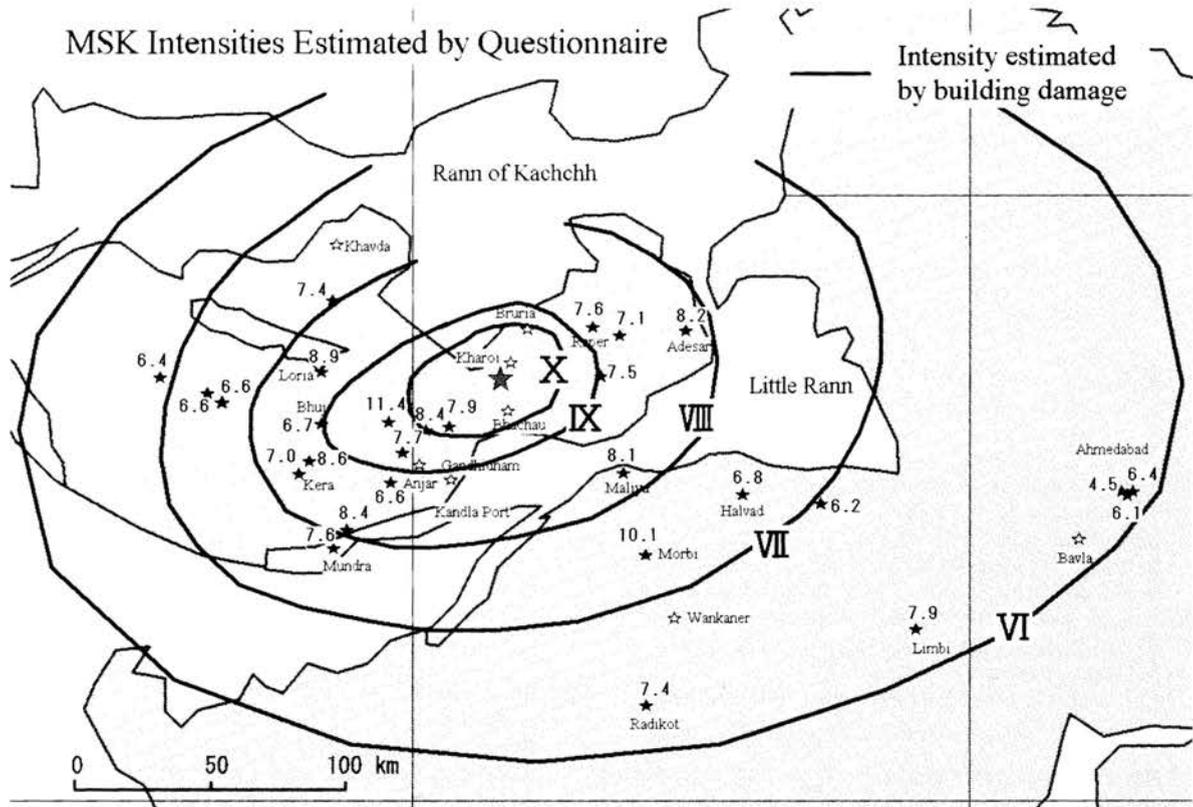
Figure 6.14. MSK intensities ( $Q\_MSK2$ ) estimated by the questionnaire method.

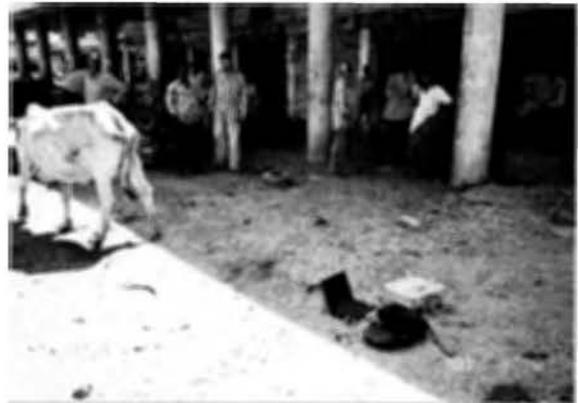
Photo 6.12. Typical circumstances around microtremor observation site.

Typical example of observation condition is shown in Photo 6.12. Spectral ratio of Horizontal to Vertical ( H/V spectrum ) is used for indicating basic natural period of the ground in the noisy environment as shown in the photo.

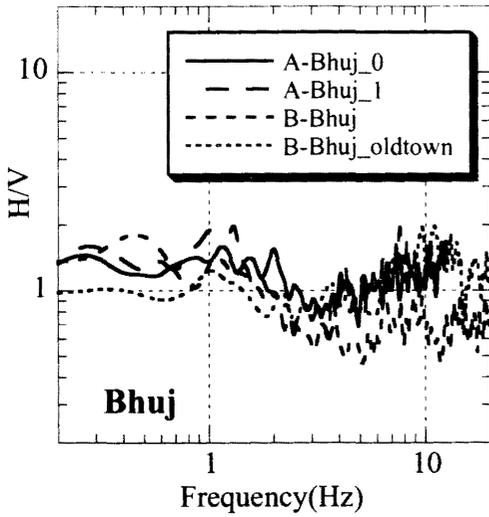
Figure 6.18. H/V spectra at Bhuj.

The differences of the results between teams are firstly examined. Two or three teams observed at Bhuj, Anjar, Bhachau and Kandla, as listed in Table 6.4. The H/V spectra resulted by the teams at those cities are shown in Figures 6.18–6.21. As the instrument used by team C was accelerometer, it is plotted in the frequency

The ground conditions in Kachchh region are discussed. Figures 6.18 and 19 show that Bhuj and Anjar are built on hard ground. On the contrary the ground at Kandla port has soft and thick surface layer

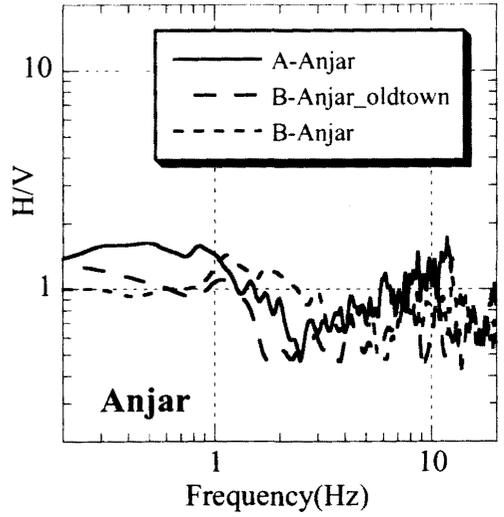
Figure 6.19. H/V spectra at Anjar.

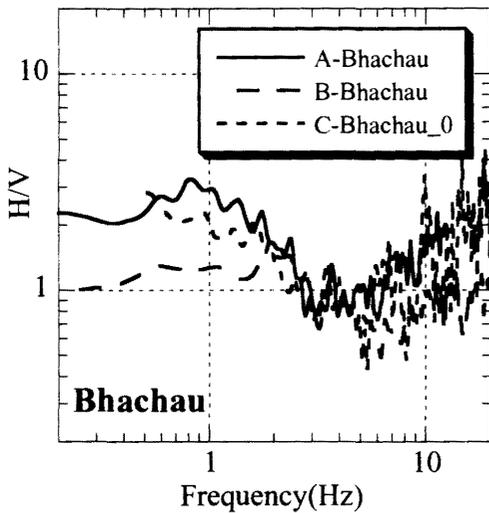
Figure 6.20. H/V spectra at Bhachau.

H/V spectra at Bhachau have two peaks, one is in high-frequency range around 10 Hz and the other around 1Hz, as shown in Figure 6.20. The former peak suggests the thin surface layer and the later implies the

complex deep ground structure. As Bhachau is located on the slope of low hill, it may affect the shape of the H/V spectra. The result at the lowland (near riverbed) in Bhachau is shown in Figure 6.23. Significant peaks at 2-3 Hz are shown and imply thicker and soft surface layer. The figure also shows the spectrum at Malia. Though heavy damage occurred in the village during the earthquake as similar as Bhachau, the ground condition at Malia is considered as good as Bhuj. The results at the several villages near Bhuj are shown in Figure 6.24. All spectra have similar

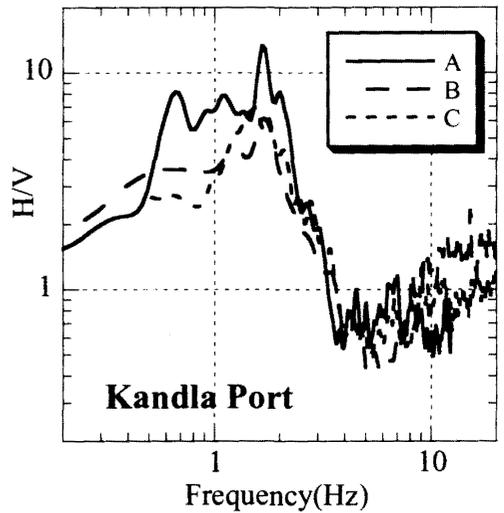
Figure 6.21. H/V spectra at Kandla.

as shown in Figure 6.21. H/V spectra obtained in two cities near Kandla port are shown in Figure 6.22. It is shown that Tuna port has the similar ground while Gandhidham has a quite different ground from Kandla port. Team C measured microtremor on ground surface at many sites in Gandhidham. Those results are shown in the section 7.2.

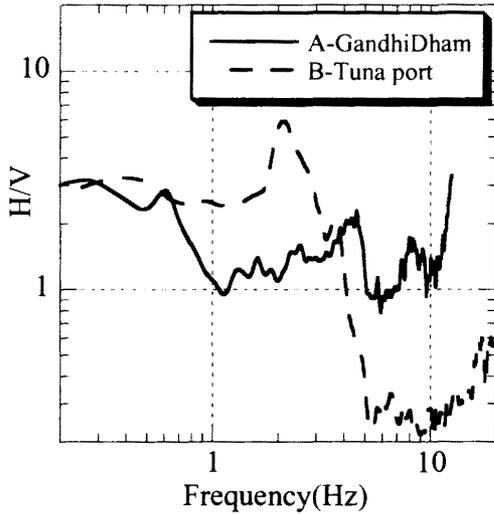
Figure 6.22 H/V spectra near Kandla port.

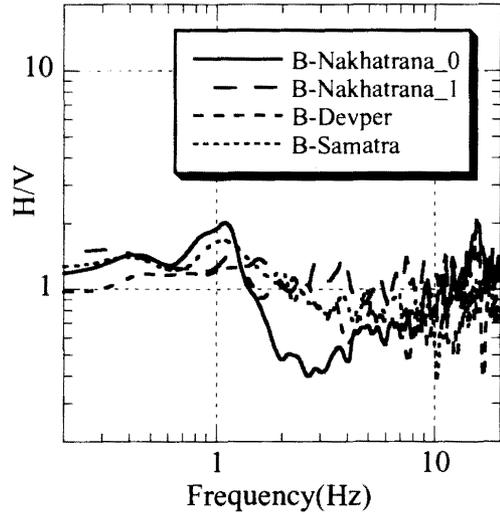
Figure 6.24 H/V spectra near Bhuj.

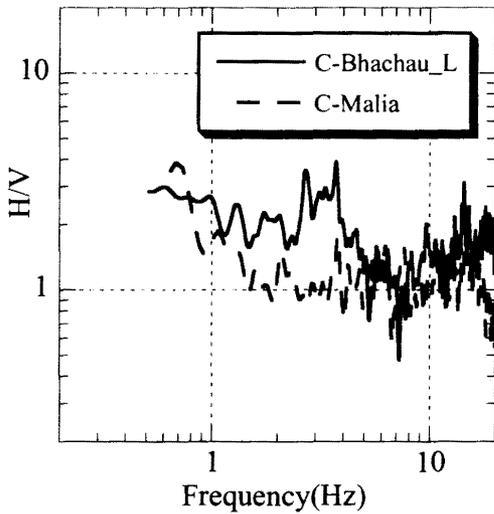
Figure 6.23 H/V spectra near Bhachau.

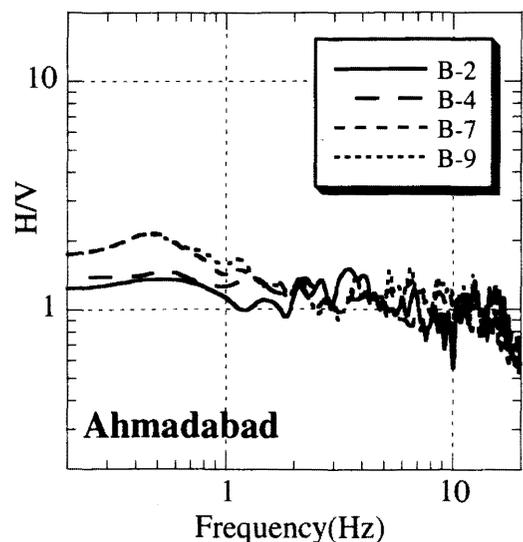
Figure 6.26 H/V spectra in Ahmadabad

Some damages occurred at the south region while slight damages at the north region of Ahmadabad. In order to examine the difference of south and north region of the city, the selected H/V spectra are shown in Figure 6.26. The spectral shapes in high frequency range over 1 Hz are similar while the levels in low frequency range are different. The peak around 0.5 Hz of B-9 site may imply the presence of thick sediment over the bedrock.
