**A Comprehensive Survey
of the 26 January 2001 Earthquake (Mw 7.7)
in the State of Gujarat, India**

Report by the Research Team
Supported by the Grant-in-Aid for
Specially Promoted Research
Provided by the Japanese Ministry of Education,
Culture, Sports, Science and Technology
in the fiscal year of 2000 (Grant No. 12800019)

December 2001

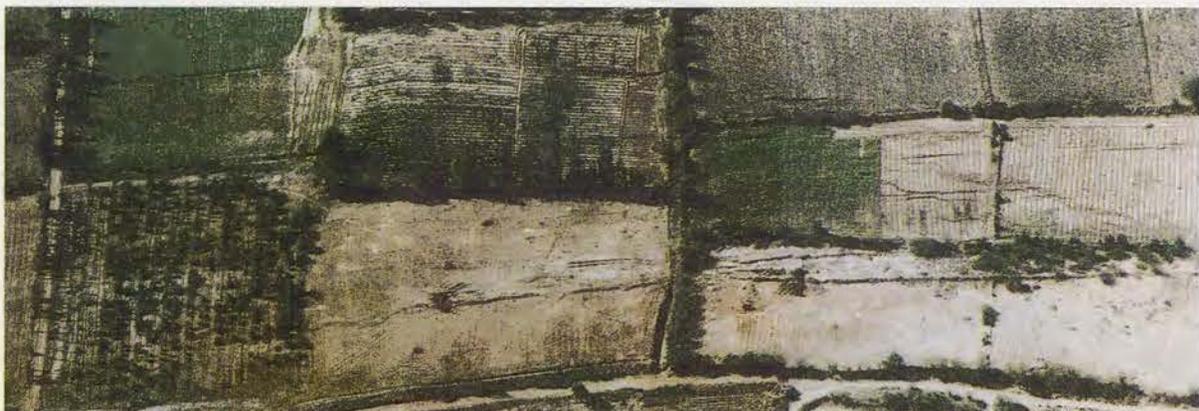
Photo 2.1. An aerial view of the cracks and linear bulges that appeared near Budharmora and Morgar (page 8).

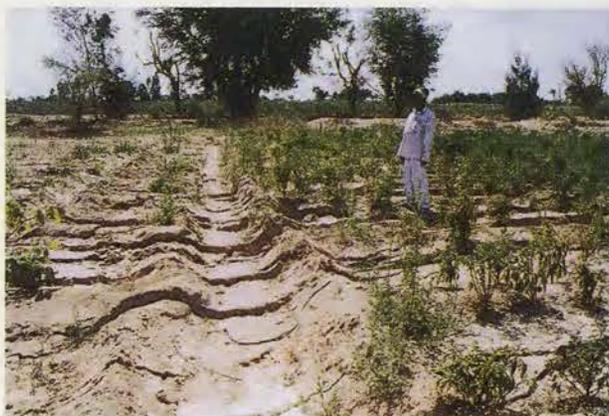
Photo 2.5. A view of typical fractures in an agricultural field near the site where a pressure ridge was observed (page 9).

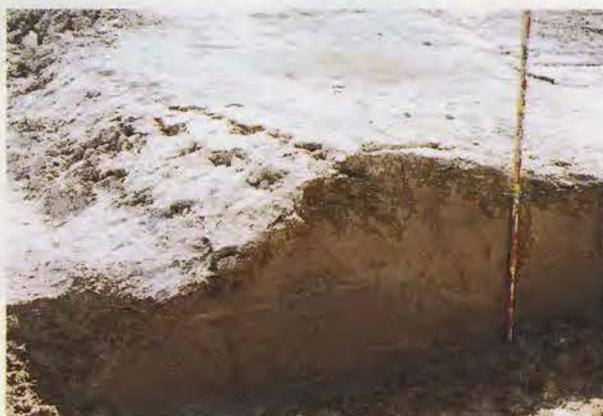
Photo 2.11. A Simple fault-bend fold deformation which appeared across the pressure ridge (page 13).

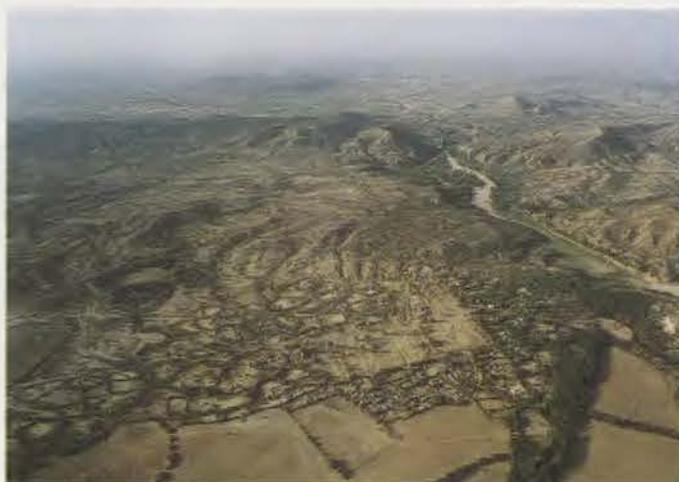
Photo 2.15. An active fault displacing and warping an alluvial fan surface at Jawaharnagar village (page 23).

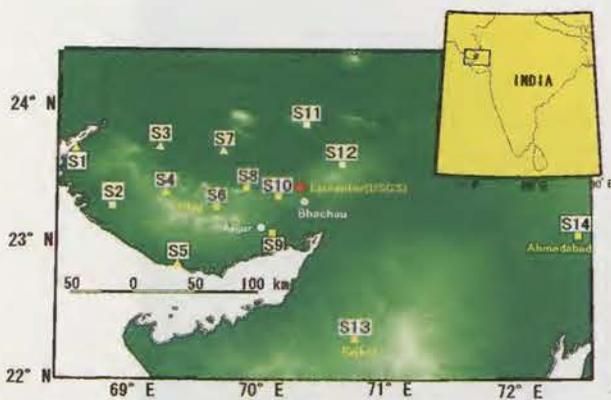
Figure 4.1. GPS network consisting of 14 re-observable stations (S1-S14). Red star denotes the epicenter determined by USGS (page 46).

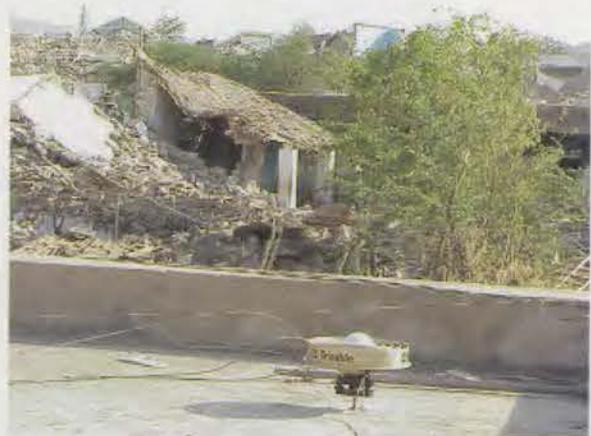
Photo 4.1 GPS antenna installed on a roof-top of a building in Lodai (S8), which was not collapsed by the earthquake. The background shows completely destroyed houses (page 46).

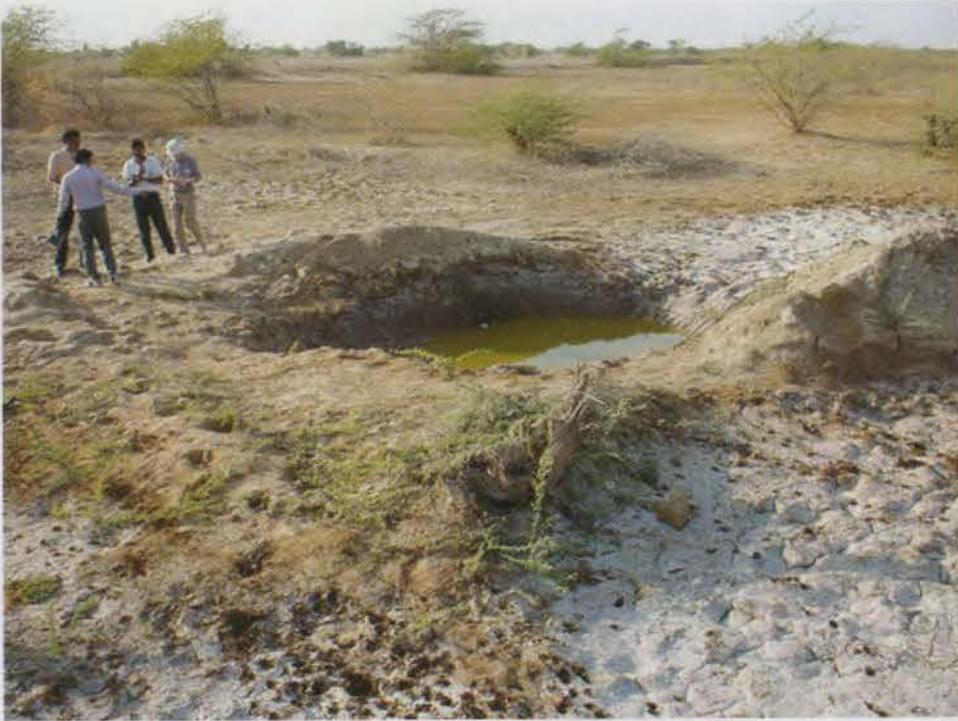
Photo 4.3 Liquefaction site. Overflowed salt water was seen around an aquifer spring (page 49).

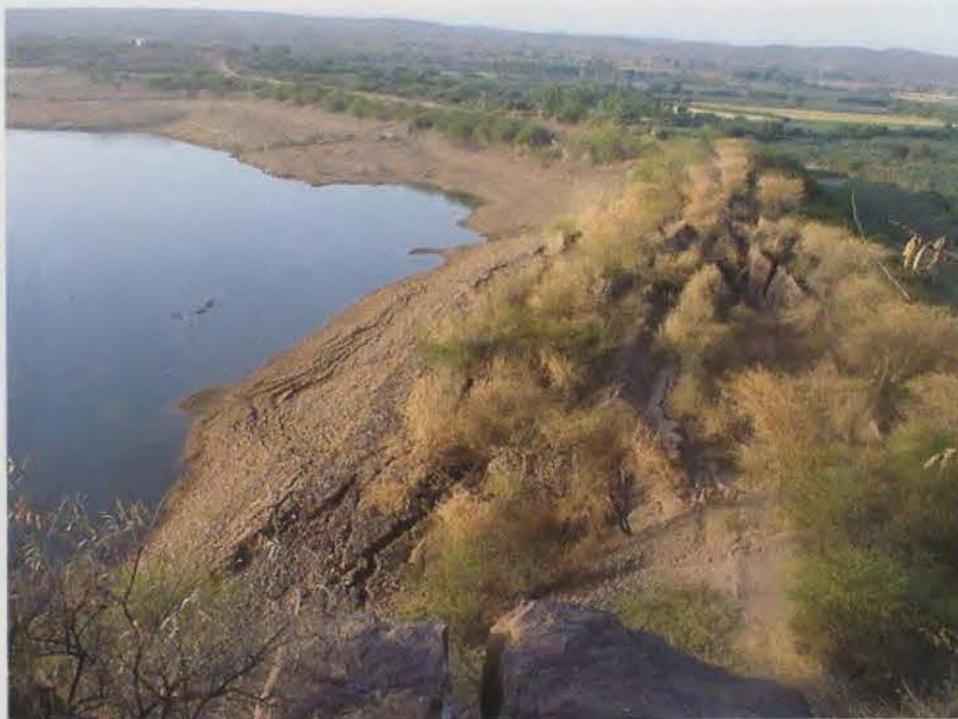
Photo 4.4. Bird's eye view of a large surface crack with a length of about 350 m, whose left portion slid down partially to the lake-side (page 50).

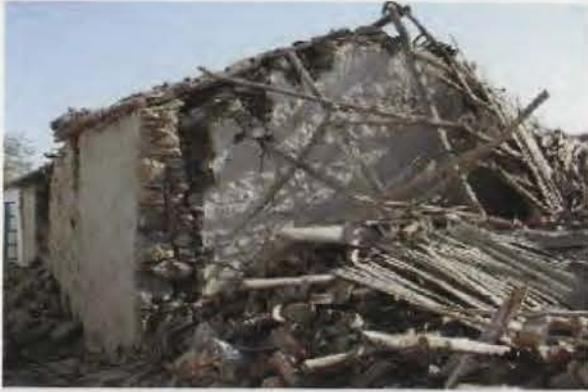
Photo 6.1. Type 1 masonry house (page 58).

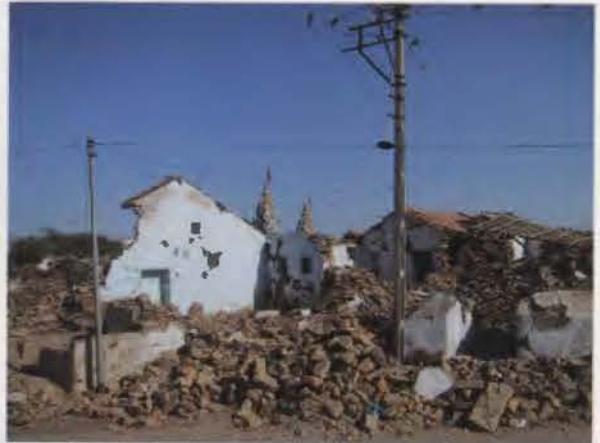
Photo 6.8. Damage of masonry dwellings in Loria, $Q_{MSK2}=8.9$ (page 68).

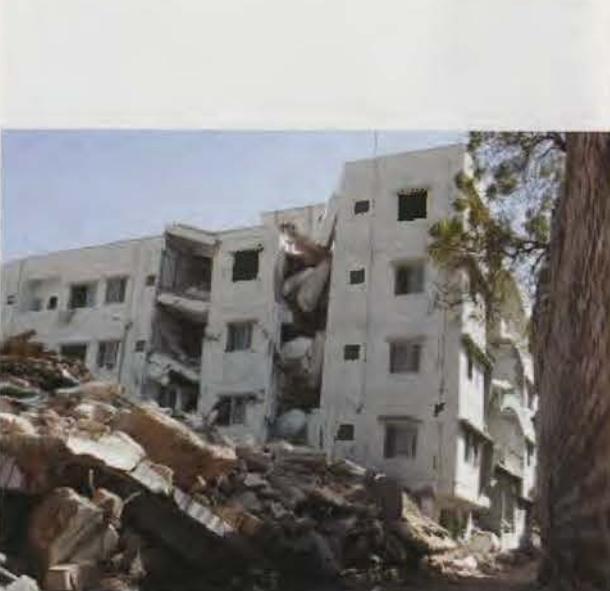
Photo 6.5. RC building with piloti (page 58).

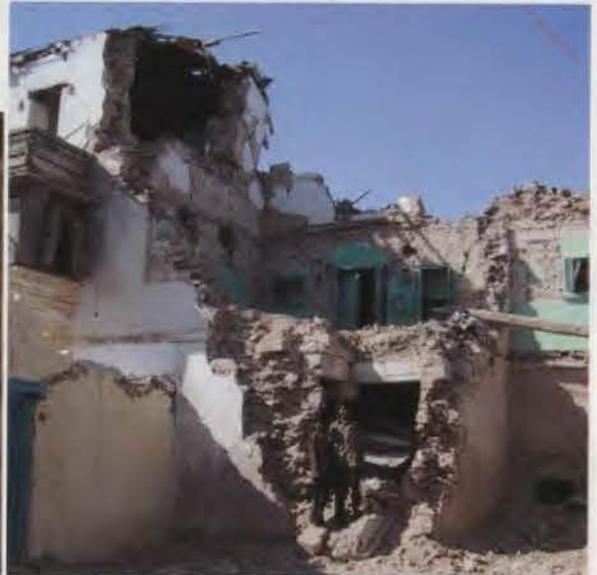
Photo 6.10. Damage in Adeser, $Q_{MSK2}=8.2$ (page 68).

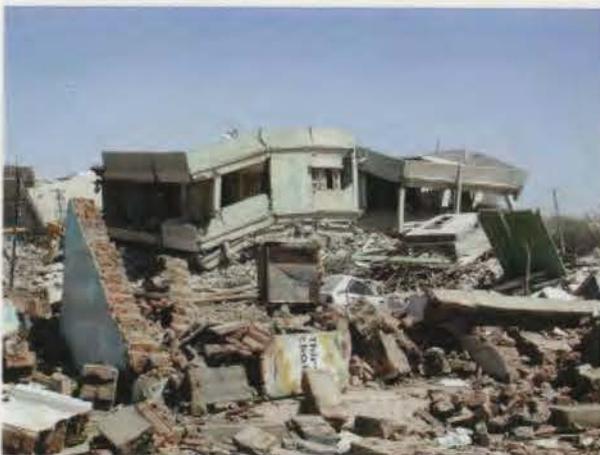
Photo 6.6. Damage to a RC building in Bhachau (page 63).

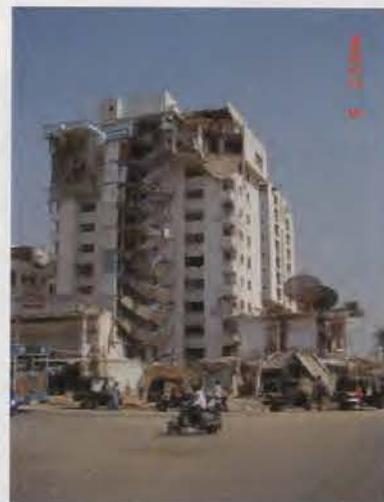
Photo 7.5. Mansi Complex collapsed because of the too much load from the pool at the top (page 78).

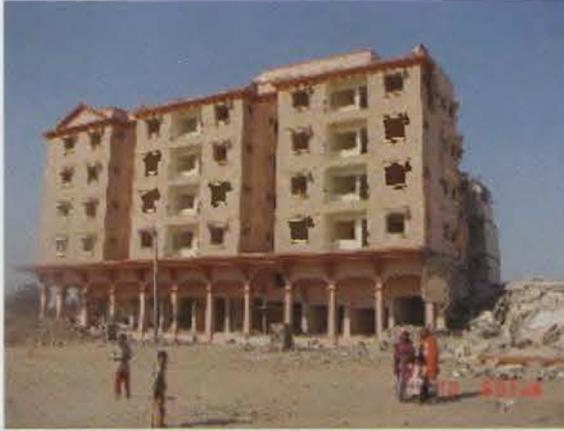
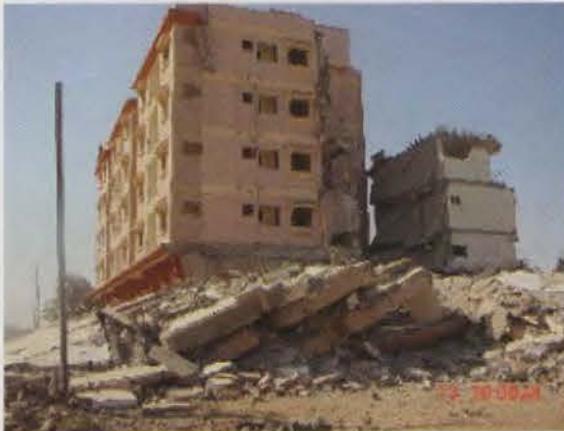
Photo 7.8 Front and side view of Pooja Flat in Anjar (page 80).

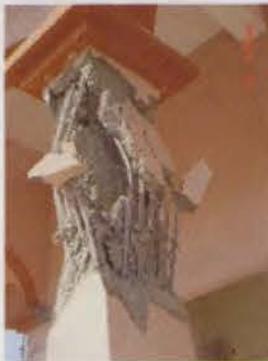
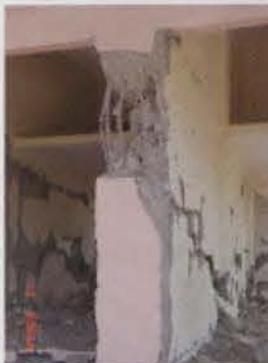
Photo 7.9. Shear failure of columns in Pooja Flat (page 80).

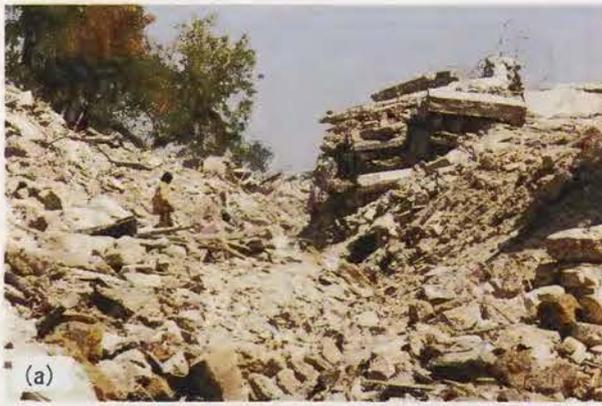
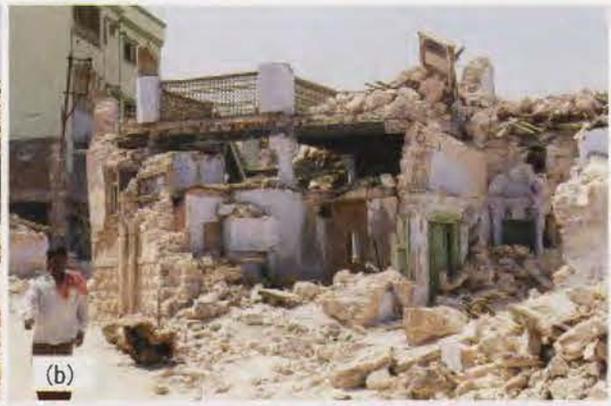
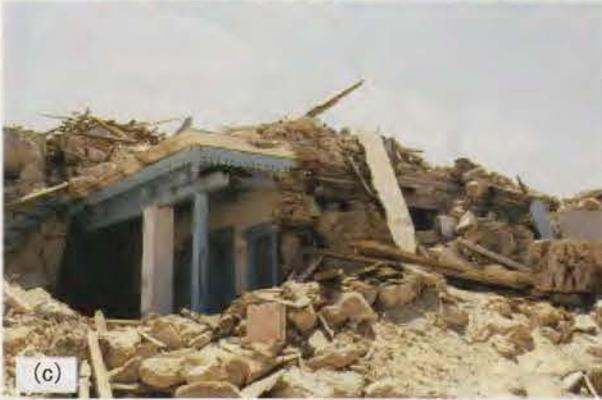
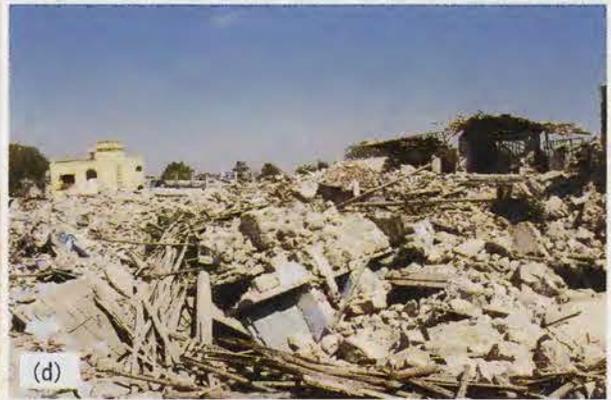
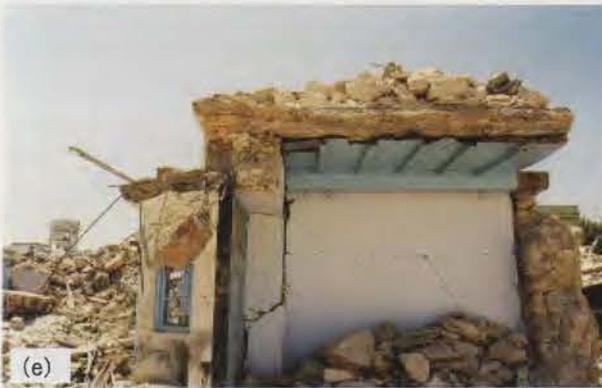
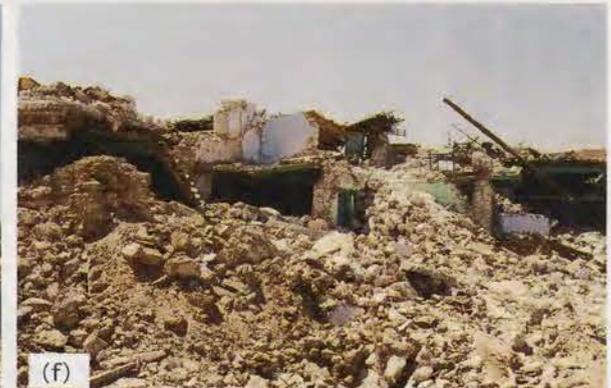
Photo 7.30. Towns where a large number of masonry houses collapsed (page 94).

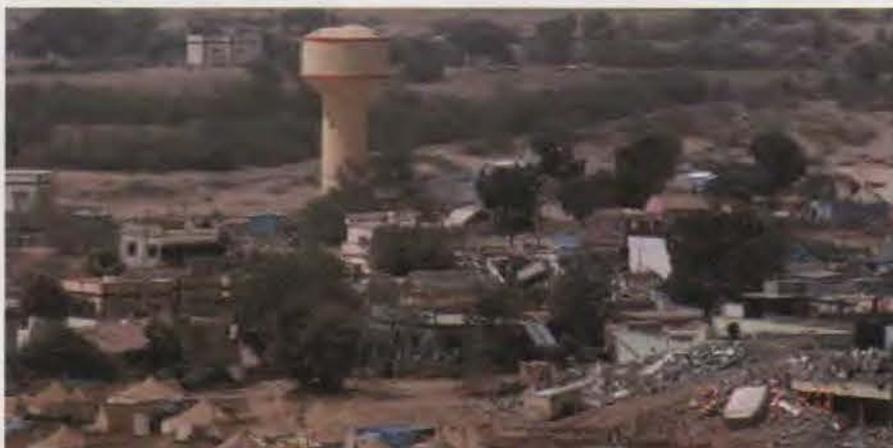
Photo 8.15. Non-damaged typical elevated water tank in Bhachau (page 114).

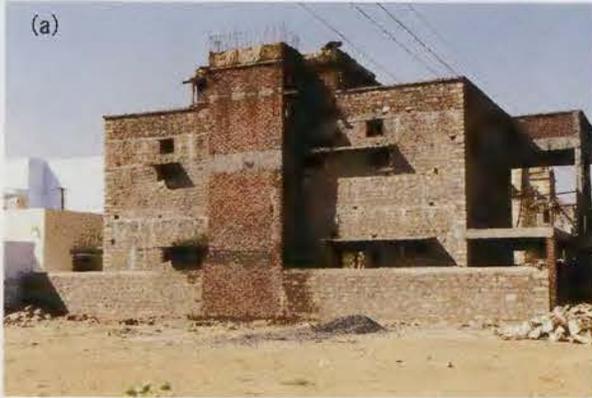
(a) Overview of the house

Photo 7.21. Two-story stone and brick masonry house with RC slab and lintel band (page 91).

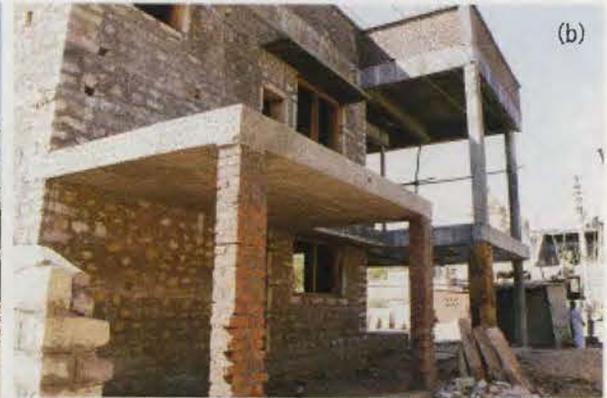
(b) The column supporting RC slab is made by just piling the bricks (Column in back side is RC).

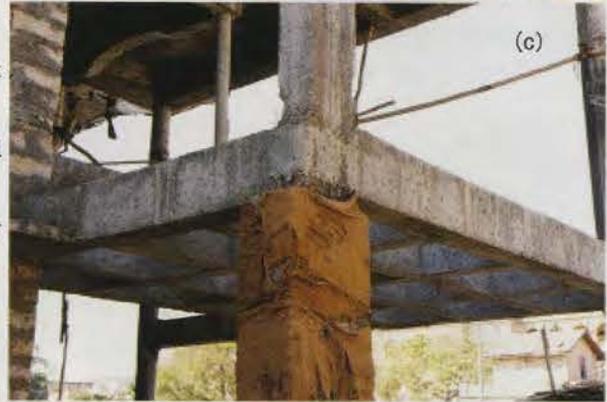
(c) Close up of the RC column (It is very slender and joint connection is poorly constructed.)

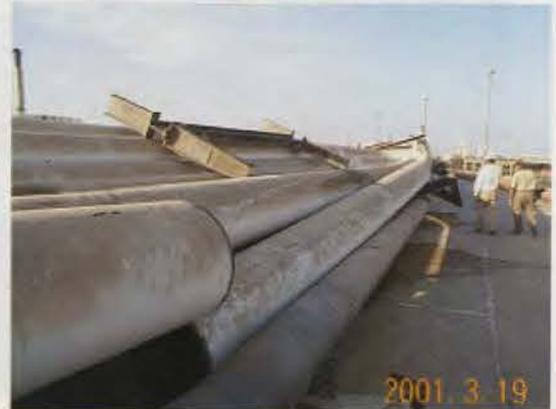
Photo 8.11. Damage to pipelines (page 110).

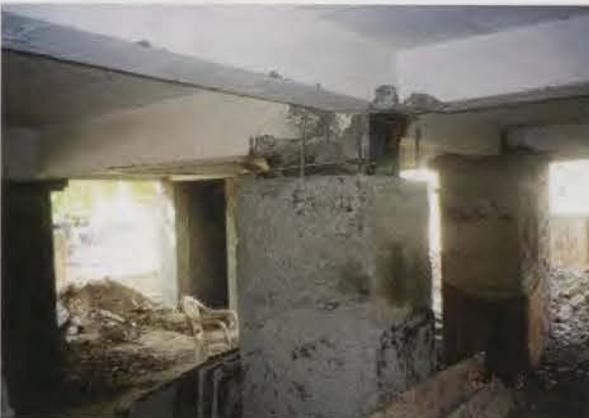
Photo 7.44. The connection between the reinforcement of the column of first story and the floor-beam of the second story was inadequate, leading to weak beam-column joint (page 104).

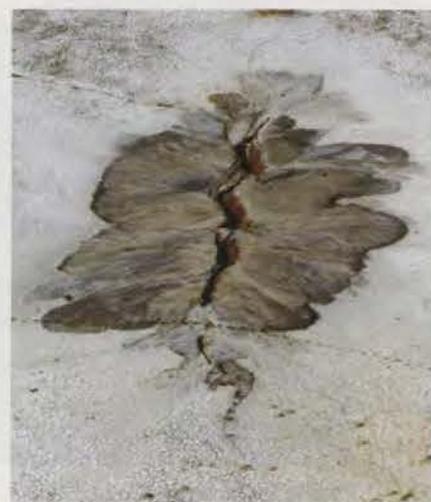
Photo 8.12. Some examples of liquefaction, Dhori (page 111).
