2. Surface Deformations and Active Faults

2.1 Surface Deformation around Budharmora

Abstract

2.2 Active Faults

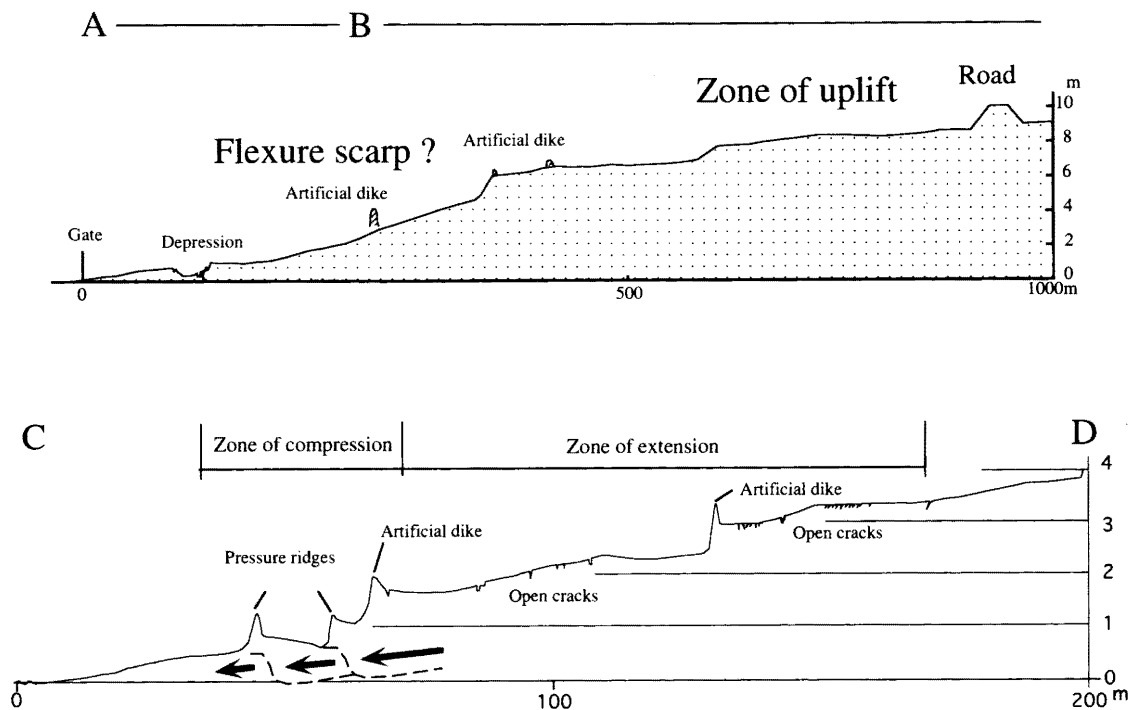
Figure 2.4. Profiles across the slope where ground deformations took place. Profile A-B is an N-S cross-section of the zone of uplift seen in Fig. 2.1. The north-facing slope where the ground deformation took place may be originally a flexure scarp associated with faulting along the tectonic margin. Profile C-D is a typical section of ground deformation seen in Photo 2.1. A zone of extension consisting of open cracks on the upper slope and zone of compression consisting of pressure ridges (linear bulges) on the lower slope clearly indicate a lateral spreading. Locations of the profiles are shown in Fig. 2.1.

cracks are confined in a zone of about 0.2 to 0.3 km wide, and extend E-W for about 1 km in length on the gently north dipping slope. Fig. 2.4 shows profiles across the slope where ground deformations took place. Profile A-B is an N-S cross-section across the zone of uplift where villages and fields are located as seen in Fig. 2.2. The north-facing slope dipping gently (2 % at steepest) may be originally a flexure scarp associated with faulting along the tectonic margin. Profile C-D is a typical section of ground deformation on the gentle slope (3 % at steepest) across the E-W striking lineament seen in Photo 2.1. A zone of extension consisting of open cracks on the upper slope and zone of compression consisting of pressure ridges (linear bulges) on the lower slope clearly indicate a lateral spreading.

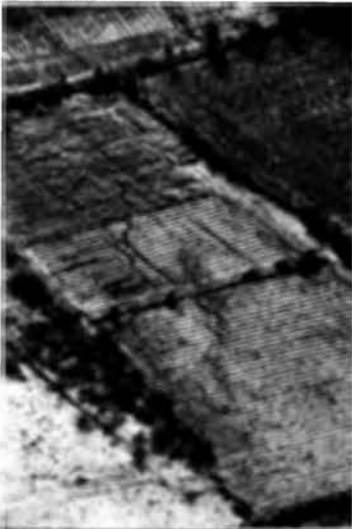
Photo 2.2. An oblique view of open cracks and bulges looking from northwest.

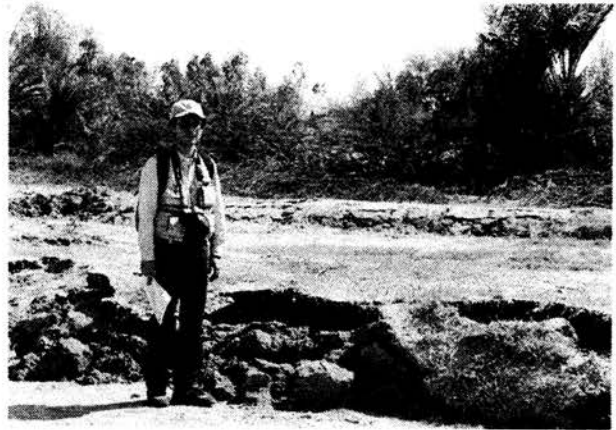
Photo 2.3. A close-up view of the linear bulges at the trench site. Looking south. Trench A was dug across the bulge far behind the standing person and trench B close behind him.

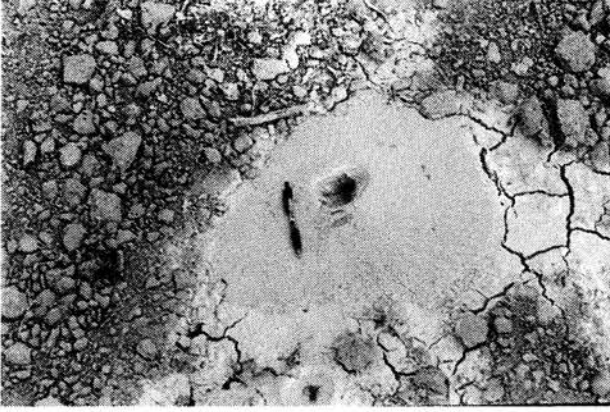
Photo 2.4. A small but typical sand blow in the field on the upper slope.

cracks striking almost E-W are composed of normal faults down-thrown to north, and associated with the rotated blocks, which resulted in the formation of series of half-graben structures under the extensional regime. Scattered wet patches on the ground (light tone in Photo 2.1) indicate that the ground water was pored out with pressure during the strong shaking. E-W extending major cracks and linear bulges are almost parallel to each other and minor en-echelon cracks trending NW-SE oblique to the major ones are convex to down slope displacing the rows of agricultural field (Photo 2.1 and 2.2). Right-lateral offsets of field patterns along the linear cracks are also observed occasionally at places. Sand blow craters ranging in diameter from several 10's cm to 1.5 m were the common features found associated with the cracking (Photo 2.4).

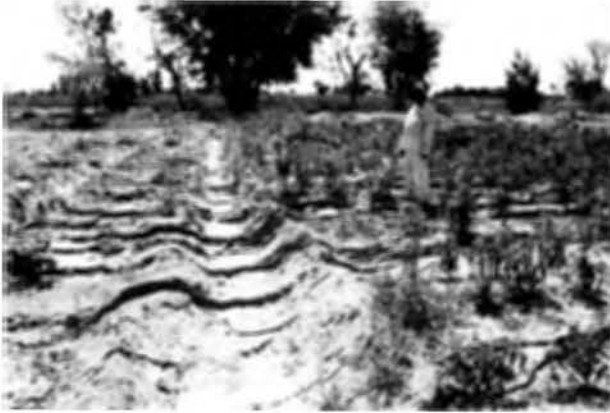
Photo 2.5. A view of typical fractures in an agricultural field. Looking south. Ruptures here are running parallel to each other and associated with north-facing steps about 10 cm high.

facing steps about 10 cm high, and generally making descending step-pattern down north (Photo 2.5), with tilting of the ground by a few degrees toward south (Photo 2.6). In the study area the intensity of the extensional cracks increases from south to north, and finally dies out with two to three E-W striking longitudinal bulges (Profile C-D in Fig. 2.4). These bulges resemble the morphology of pressure ridge. Opening of the cracks varies from less than 1 cm to 25 cm wide, and total amount of expansion roughly matches to the amount of shortening revealed by trenching across the bulges.

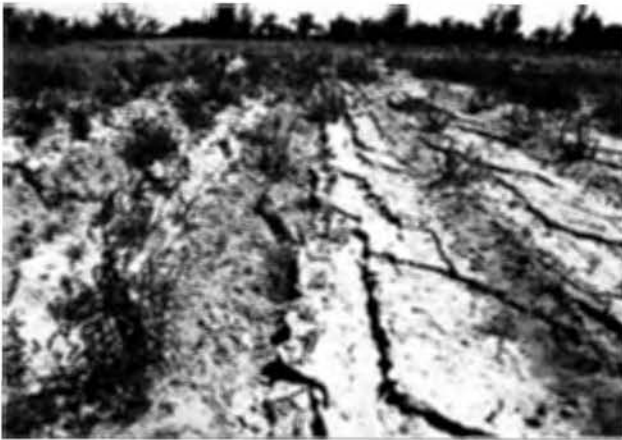
Photo 2.6. A parallel view of the ruptures in Fig. 2.5, looking east. The ground is fractured by extensional faults spaced by tens of centimeters to a meter and is tilted by a few degrees toward south.

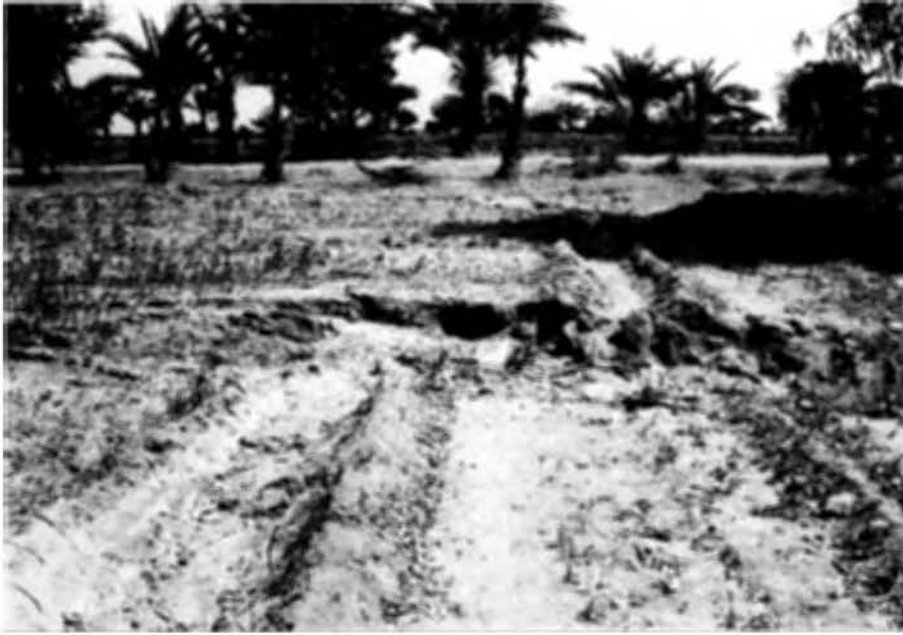
Photo 2.7. An apparent right-lateral offset of an irrigation channel along an N-S striking fracture in an agricultural field, looking east. The ground in front of the fracture is locally moved northward due to lateral spreading in a highly moist soil close to a pond in the upper slope to the south.

An apparent lateral offset along an N-S extending fracture is locally formed due to lateral spreading in a highly moist soil close to a pond in the upper slope (Photo 2.7). An irrigation channel along the fracture is offset about 1.2 m right-laterally, but the rupture disappears quickly to the north. Most of the

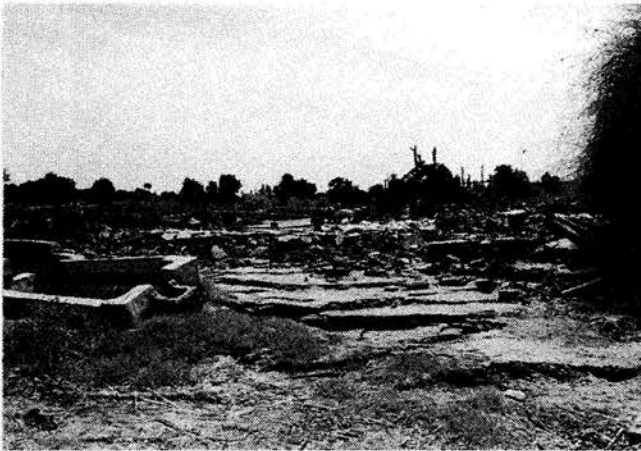
Photo 2.8. Right-stepping fractures causing total destruction of a farmer's house just on them. Looking southeast.

houses in the vicinity of the study area were destroyed by severe ground shaking, and some houses were destroyed because they were just on fractures as seen in Photo 2.8.

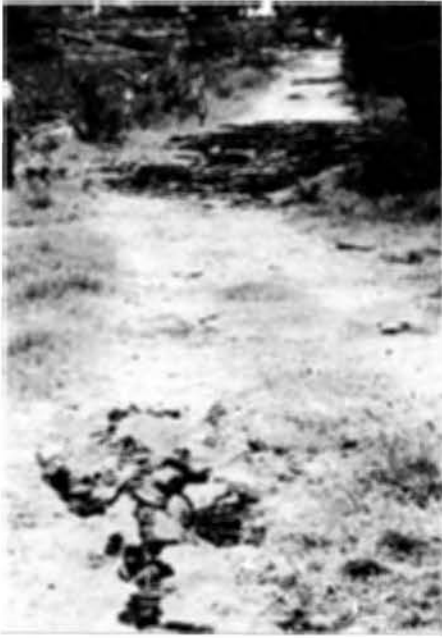
Photo 2.9. A relatively large depression formed between extensional faults down to the north and those down to the south. The depression is located in the lower slope in the profile A-B in Fig. 2.4.

The cracks down-thrown to both north as well as south have resulted in a development of small depressions at places. A relatively large depression of this kind was observed in the Profile A-B in Fig. 2.4 (Photo

2.9). The depression is located in the lower slope in the profile A-B. Photo 2.10 is a close-up view of the north-facing steps in Photo 2.9. The ground across the fractures slumped about a meter to the north by densely spaced extensional faults, and fractured surfaces were rotated with dip to the south.

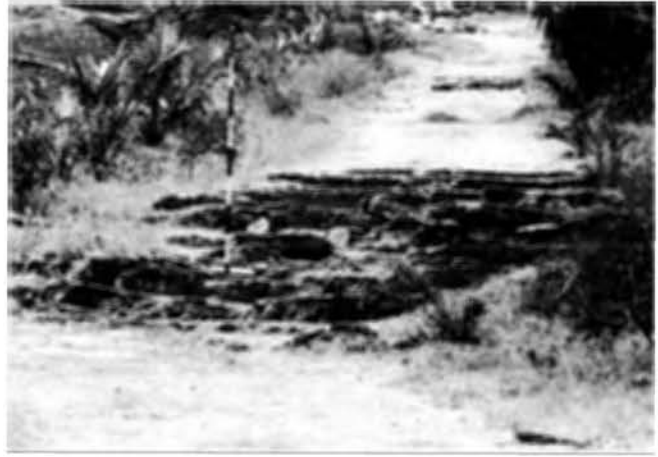
Photo 2.10. A close-up view of the north-facing steps in Photo 2.9. The fractured ground slumped about a meter to the north by densely spaced extensional faults.

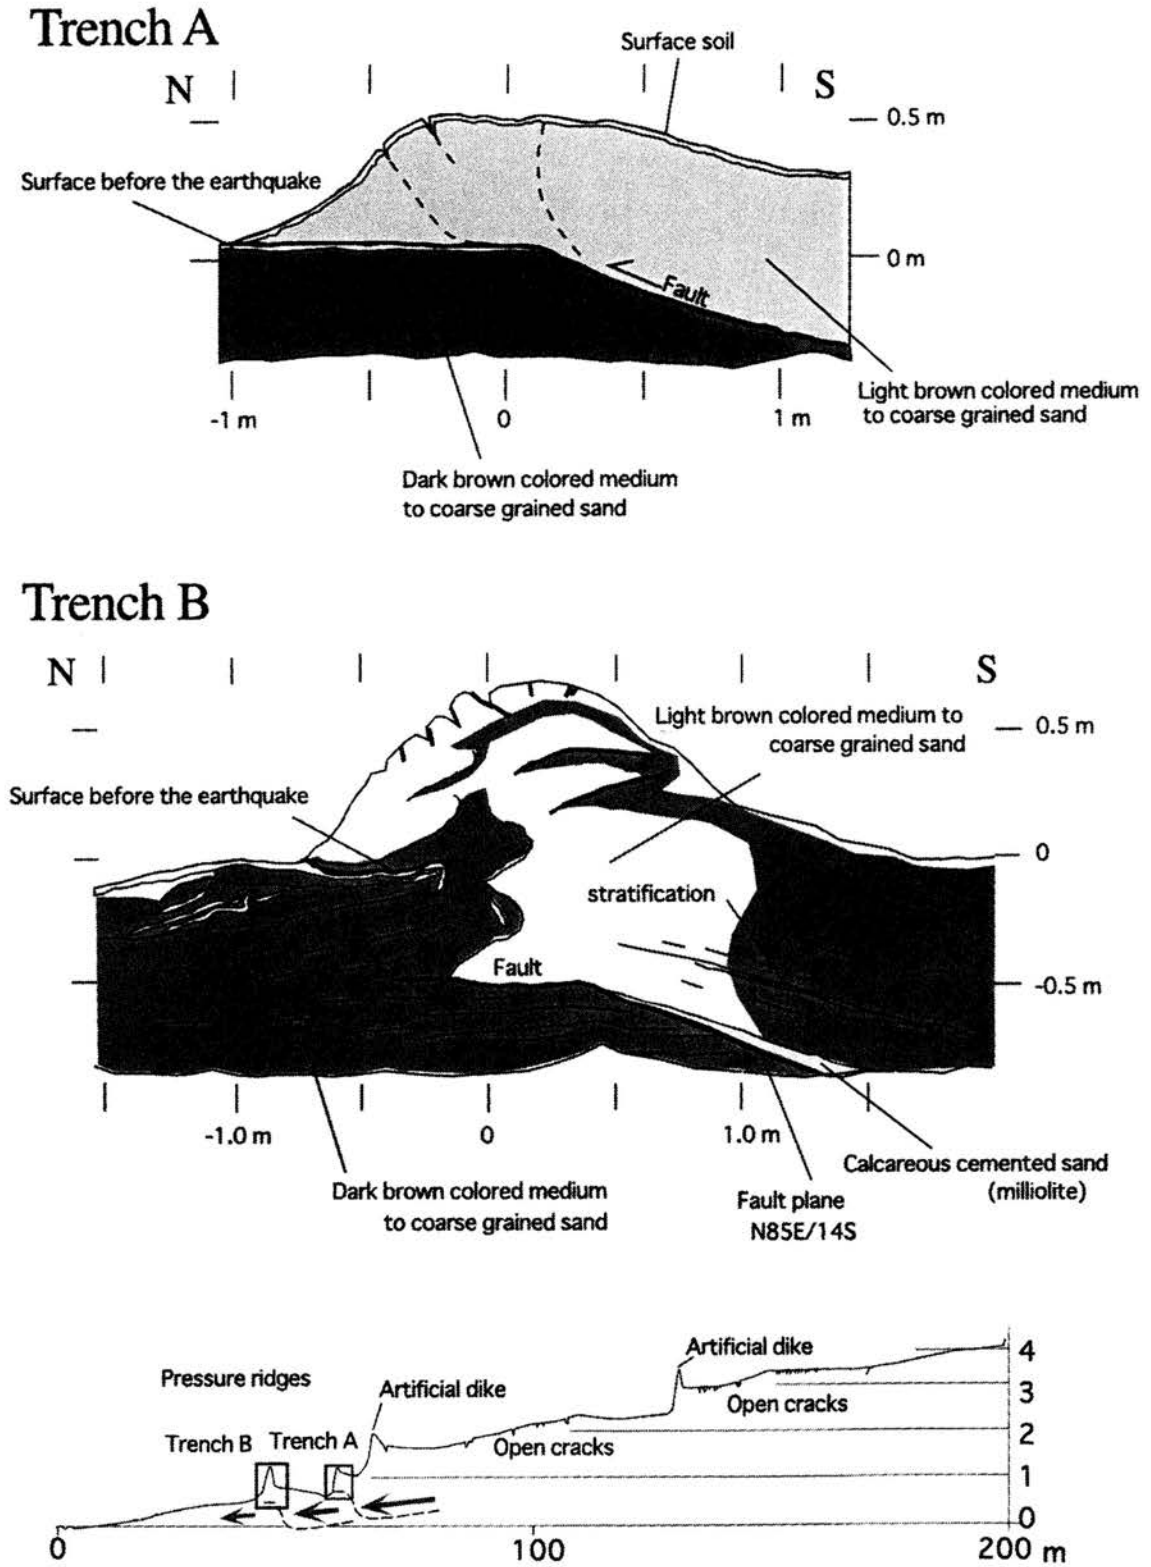
Figure 2.5. Logs at Trench A and B. The trench walls demonstrate typical thin-skinned tectonics. Trench A indicates a simple fault-bend fold, while trench B suggests fluid deformation at the toe of over-thrusting surface layers. Locations of the trenches are shown in the profile at the bottom.

brown in color that is probably due to difference in moisture content. Both trench walls demonstrate a typical thin-skinned tectonics. The sand layers partially cemented with calcareous material locally called as Miliolite is intercalated along the fault plane. Photo 2.11 shows simple fault-bend fold deformation at trench A, while trench B suggests over-thrusting surface layers

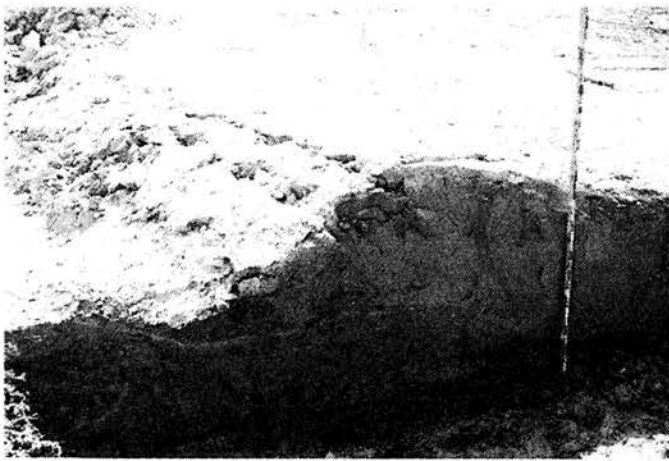
Photo 2.11. Simple fault-bend fold deformation appeared in the trench A, looking east.

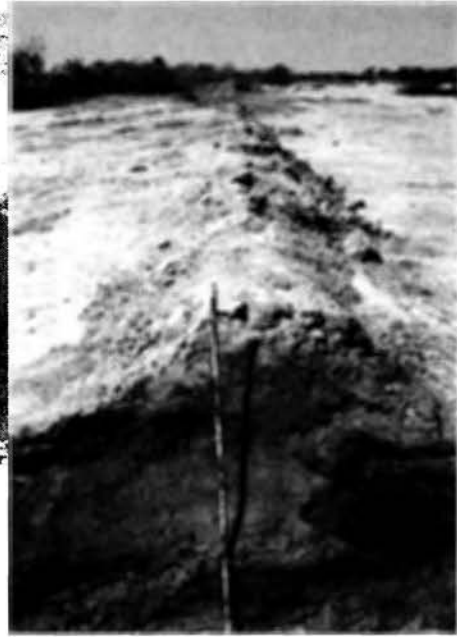
Photo 2.12. Over-thrusting surface layers forming linear bulge at trench B. A rather complicated structure on the trench wall may be due to fluid deformation.

forming linear bulge with fluid deformation at the toe of hanging wall (Photo 2.12).

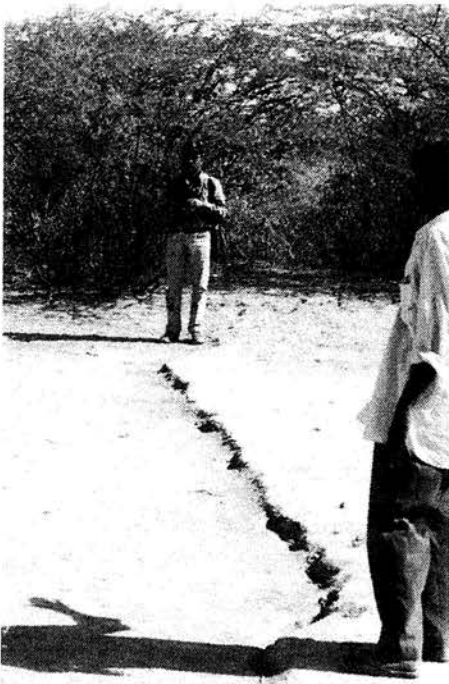
Photo 2.13. Distinctive cracks near village Umedpur, located north of Lodai. These cracks are in N-S direction, and are characterized down to north and shows apparent right-stepping pattern.

observed. These fractures are characterized by a vertical separation of 10 cm down to north, and show apparent right-stepping pattern along with 10 to 20 cm left-lateral movement (Photo 2.13). These fractures well resemble the Manfara fault NSF-SCEC Team (2001) mapped northeast of the USGS epicenter. Judging from the photographs and description in their web site (NSF-SCEC Team, 2001), the Manfara fault with right-lateral strike-slip is still dubious to be a tectonic feature because the fractures occurred close to the boundary between bedrock exposure and alluvium. Unconsolidated sediments with different thickness often result in ground rupturing under a strong shaking.

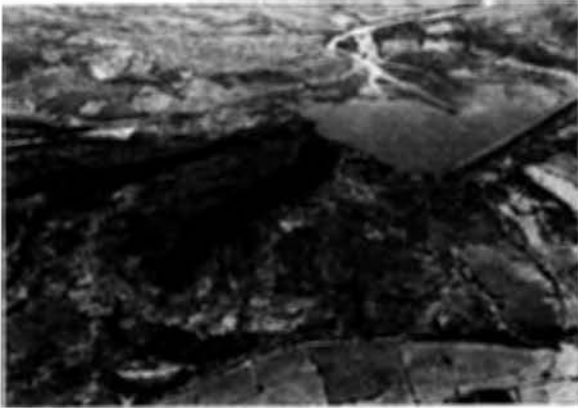
Photo 2.14. Active fault trace on the right bank of Kaswali river, east of Lodai village. Probably this fault is an extension of the fault observed on the left bank. The fault has displaced fan surface resulting into north facing fault scarp. View looking south.

Photo 2.14). The scarp is about 5 m high across the higher fan surface and about 20 m across the lower surface, suggesting cumulative fault slip. This fault extends for more than 1.5 km and probably further west it connects the active fault near Dhrang. However, it does not show any significant surface trace in field as well as on the satellite photo. The eastern extension of this fault runs north of Lodai village. Here it has clearly displaced the fan surface on which Lodai village is located giving rise to 5 to 7 m

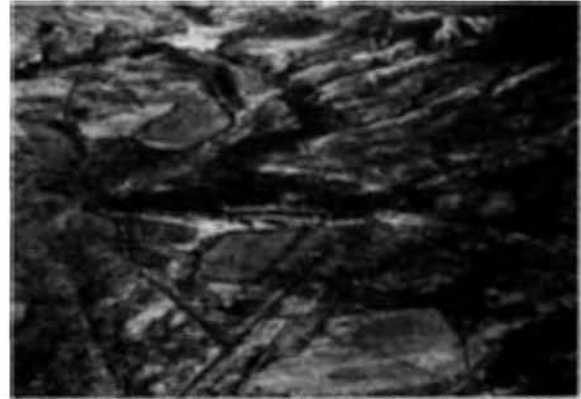
Photo 2.16. E-W trending active feature/fault trace (?) cutting through the colluvial debris in the pediment zone along Katrol Hill Range north of Hamadra Talai. The longitudinal stream flowing parallel to the range front follows the fault trace.

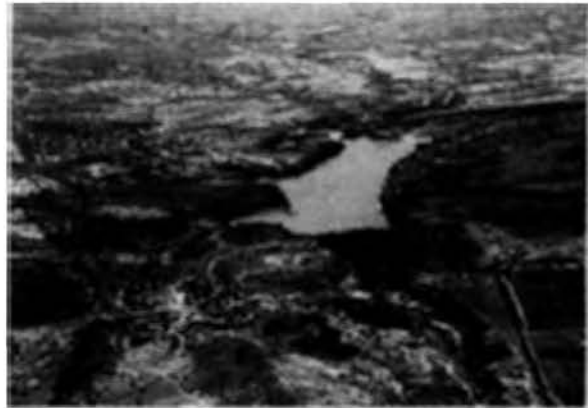
Photo 2.17. Eastern extension of active fault trace aligned along the range front of Satpura Dungar cutting colluvial debris near Ler Village, marked by sharp straight escarpment delineating contact between the alluvium in pediment.

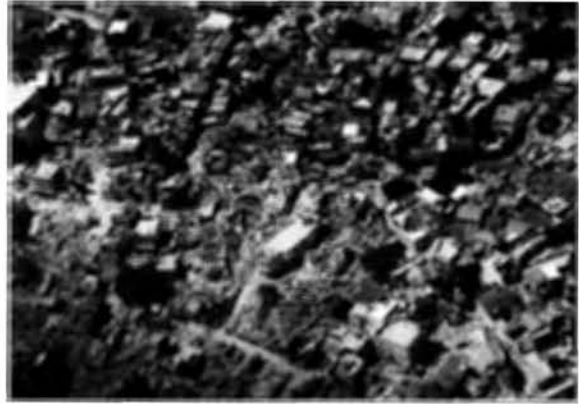
Photo 2.19. Aerial view of damage at Anjar. Note that only the centre of the town was seriously affected by this quake.

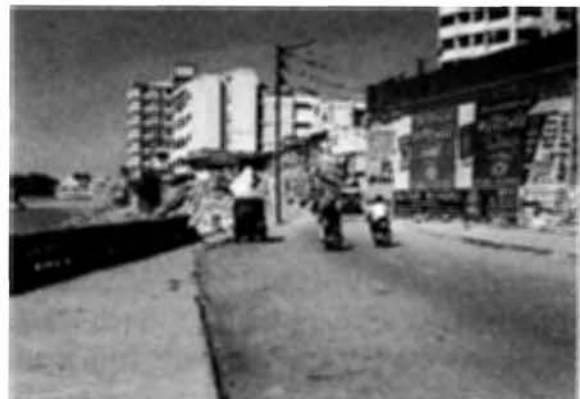
Photo 2.21. Alampana Fort after the earthquake.

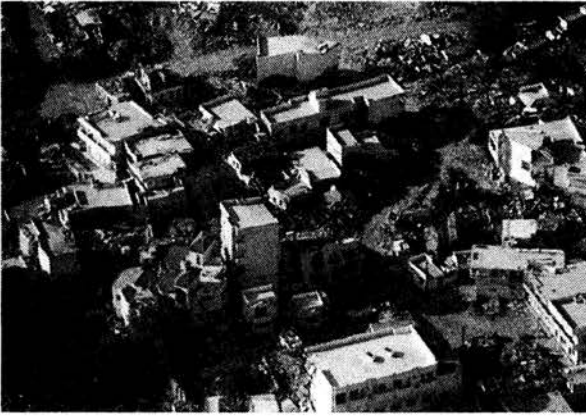
Photo 2.23. Aerial view of destruction at Bhachau.

Our regional observation reveals that the towns and the villages located in the vicinity of the epicentral area were fully damaged. Bhachau (Photo 2.23) and Vondh which are located on the rocky platform of Mesozoic sandstone and villages like Budharmora, Morgar, Amardi, Dhamadka, Jawaharnagar etc. located on the soft unconsolidated sediment succession the destruction was nearly similar, irrespective of the ground condition. We found that comparatively less damage occurred in the towns like Bhuj, Anjar, Ratnal etc., which were located far from the epicentral area, particularly with the

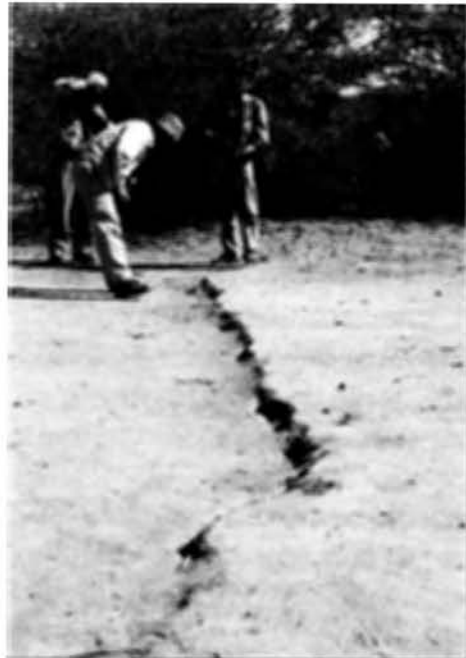
Photo 2.26. N-S striking extensional surface cracks at Umedpur in Banni Plains. Cracks show sinuous pattern. Apparent left-lateral movement results into formation of small pull-apart. Displacement is about 10-20 cm.

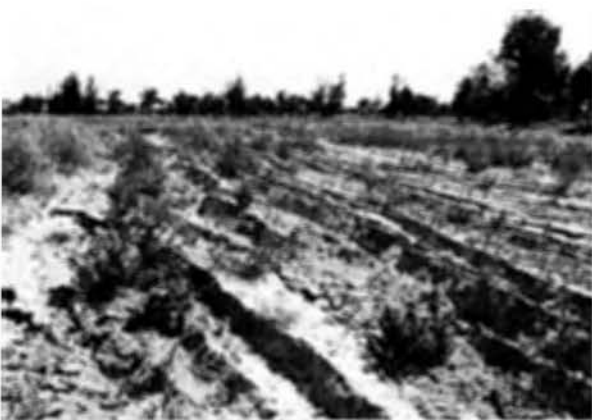
Photo 2.25. Lateral spreading resulted in the development of sub-parallel extension cracks or normal faults with down throw due north. Extensional faulting has give rise to development of stair-case pattern at Budharmora. View looking east.
