7. Building Damage

7.1 Damage of Reinforced Concrete Structures

S. Kono and H. Tanaka

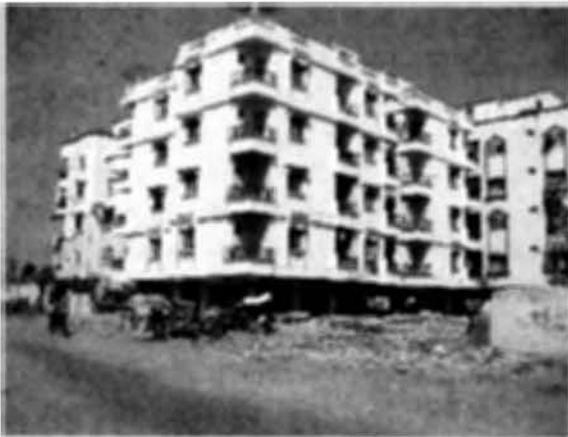
Photo 7.1. Typical five-story RC building.

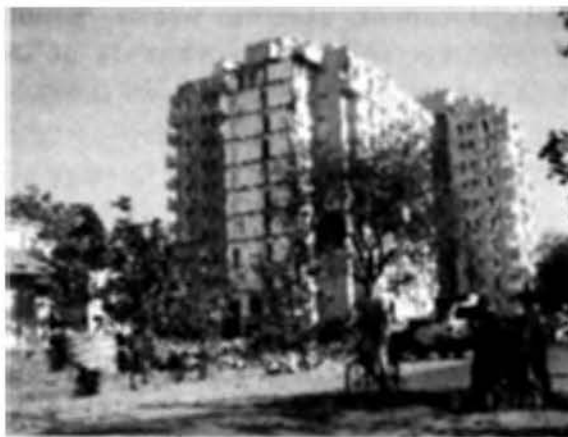
Photo 7. 2. Typical eleven-story RC building.

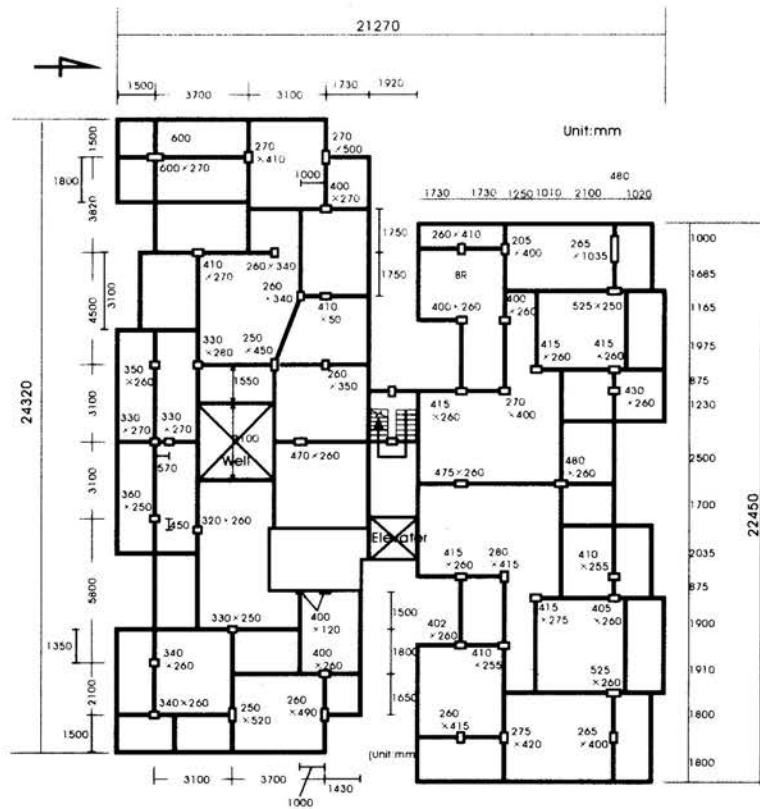
Figure 7. 2. Plan drawing of Block C in Akshar Deep Flat show irregular column arrangement.

Akshar Deep Flat had three five-story RC buildings with penthouse on the top and parking on ground floor. The penthouse was used as the part of the residence of fifth story. Two buildings collapsed in a pancake manner and the only one building withstood with heavy damage. As seen from Figure 7. 2 and Photo 7.6. , the floor plan and column arrangement is irregular and some beams are eccentrically connected to columns. The floors of second and upper had 2 m cantilever floor hanging out from the outermost column resulting in a

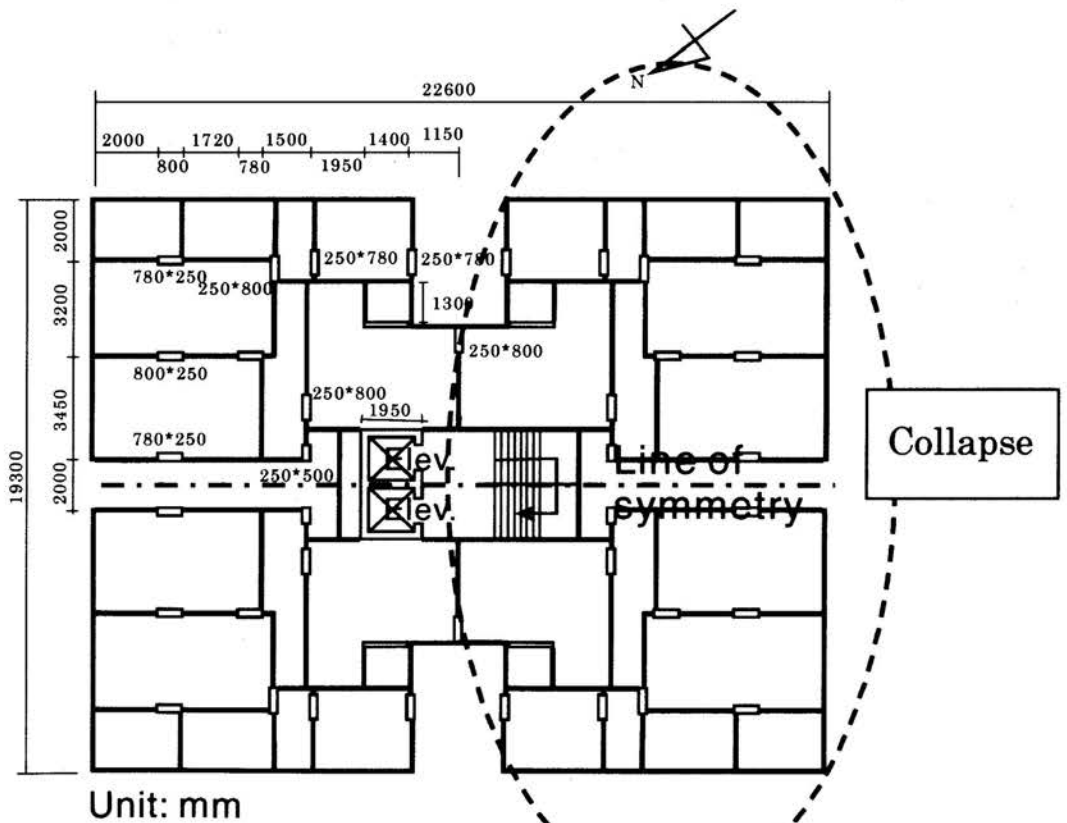
Figure 7. 3. Plan drawing of 11 story Mansi Complex.

Extra floors and water tanks, added at the top of the building without strengthening the columns, further increased damage. For example, one of the most devastating failures of buildings was that of Mansi Complex constructed in 1994 in Photo 7.5, whose plan view is shown in Figure 7. 3. This eleven-story building had a soft ground floor with strong beams and weak columns. The half of the buildings split from the lift core and collapsed resulting in 46 casualties while the other half part in Photo 7.5. is still standing. Poor design practice, shallow foundations, and improper detailing caused the shear failure of columns at the ground floor. Additional loads of swimming pool and water tank without strengthening

the columns worsen the vulnerability. The half of the building did not collapse as the connecting beams and slabs failed due to improper embedment of reinforcement.

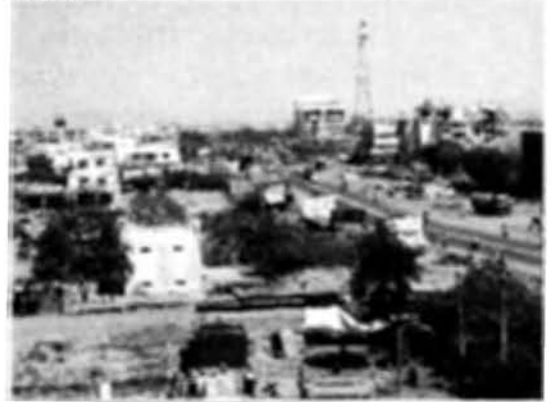
Figure 7.6 shows the town map of Gandhidham city. Damage concentration was observed in an enclosed area in Fig. 7.6. The sites of heavily damaged buildings are shown in Fig. 7.7. Photo 7.12 shows a bird's view of the district and the main street of Gandhidham, which runs from west to east. The heavily damaged district is in the vicinity of the old town. However, we had hardly seen severely damaged buildings in the old town as shown in Photos 7.13 and 7.14. The buildings of this area are mainly two storied row houses and their structures are reinforced concrete framed masonry. This block of the town was established in 1950s, and therefore, is the oldest in Gandhidham city but far newer than towns like Bhuj or Bhachau.

Photo 7.12. Bird's view of the newly developed town district of Gandhidham

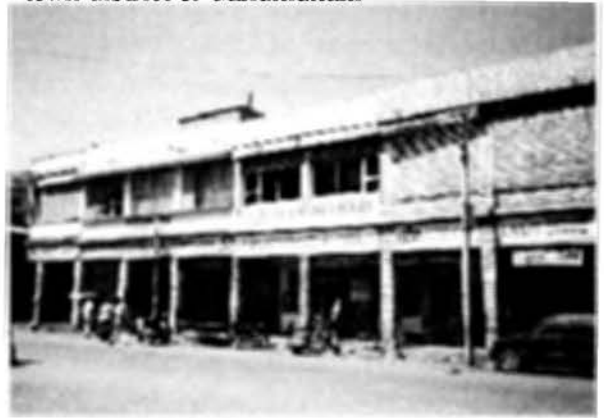
Photo 7.13. Buildings along the center street in the old town of Gandhidham

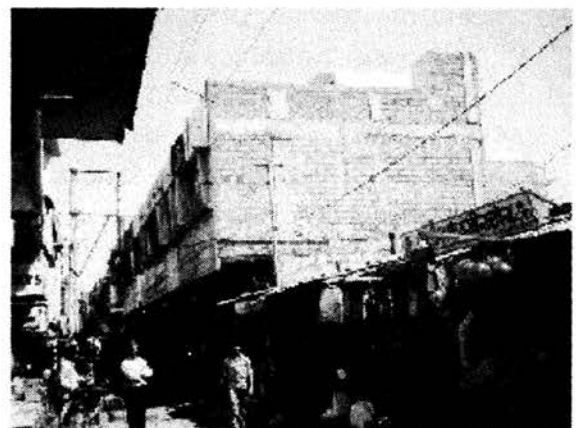
Photo 7.14. Buildings along the center street in the old town of Gandhidham (side view)

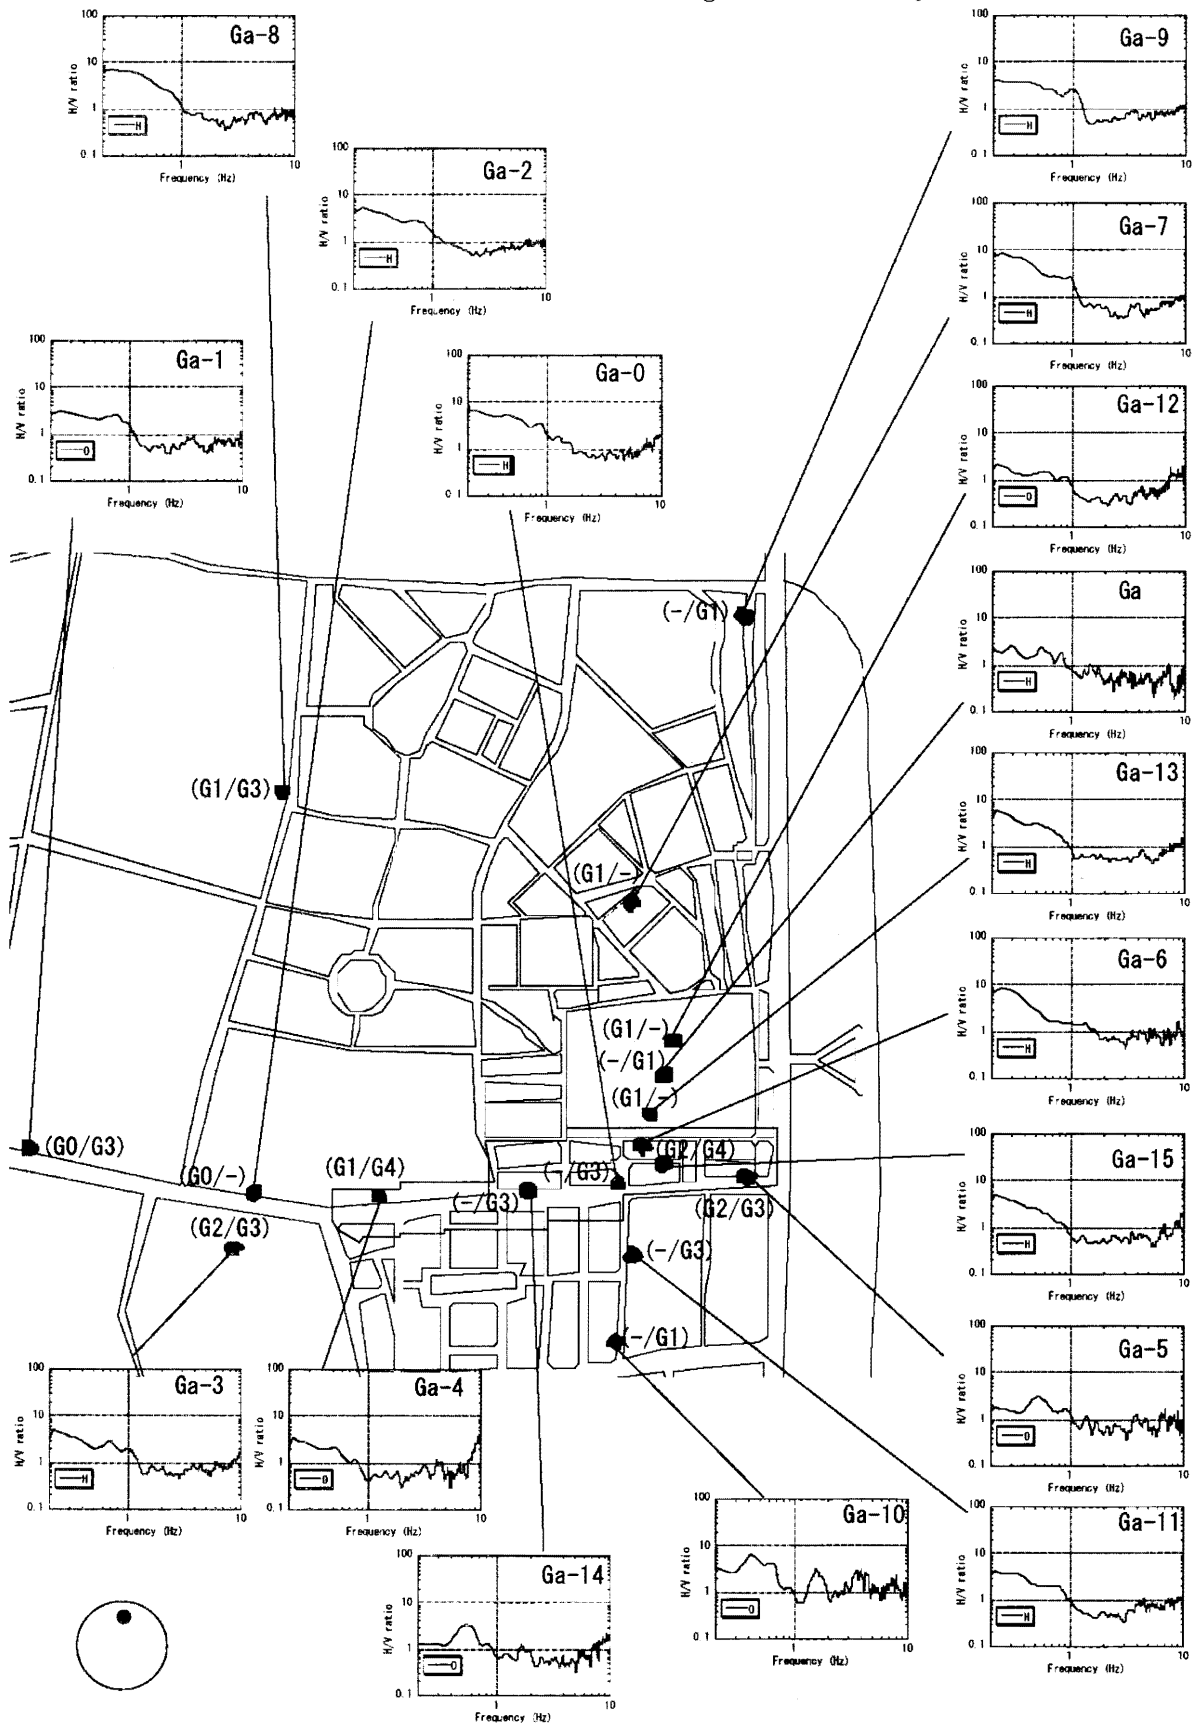
It is clear from Fig. 7.8 that RC buildings have generally higher grade of damage compared with masonry buildings. Moreover, damage grade along the main street is the highest in the whole Gandhidham. On the other hand, there are some sites whose H/V spectra have peaks corresponding to predominant frequency of the surface soil layer. However, we cannot recognize any clear tendency in H/V spectra that explains the difference between damage degree of damage concentrated area and that of the others. Judging from H/V spectrum obtained from microtremor measurement, the soil conditions at most of the places in Gandhidham city are very good and the soil condition could not account for the damage concentration of buildings along the main street.

Figure 7.8. Building damage and predominant frequencies of the soil.

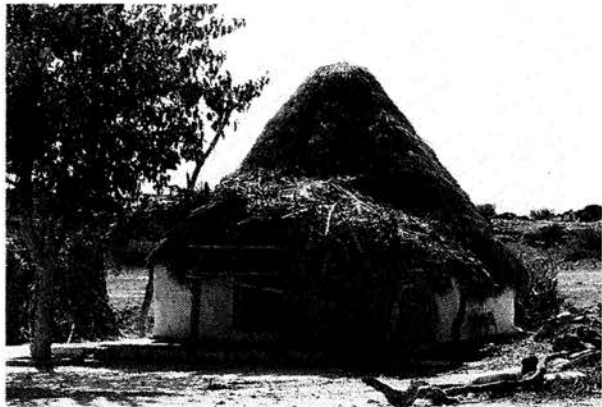
Photo 7.15 Traditional masonry house called Bhonga

roof is usually made of straw. Generally, the *Bhonga* have one singly room, i.e. there are not interior partitions. The main feature of this structure is its cylindrical shape, which provides it with a better seismic performance when compared with the commonly used rectangular shaped structures. Due to its axisymmetry, the *Bhonga* exhibit good seismic performance no matter which is the earthquake direction. On contrast, the rectangular shaped structures tend to concentrate stresses at the corners causing damage at these regions and eventually the separation of adjacent walls.

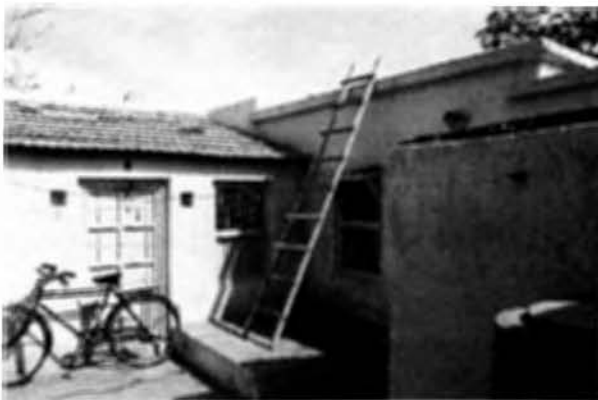
Photo 7.16 Single-story brick masonry house constructed in 1956

Photo 7.16 shows a house that did not suffer any major damage. It was constructed in 1956 just after the Anjar earthquake. While in other cities, the newer the house, the stron-

ger it was, in Anjar, older houses tend to be stronger than new ones. The reason for this is that after the Anjar earthquake, the entire city was relocated and house construction quality was given proper attention. Only one-story buildings were built in the newly developed town. Unfortunately, the awareness of earthquake related problems and attention to seismic strength of structures did not endure and decreased as time passed.

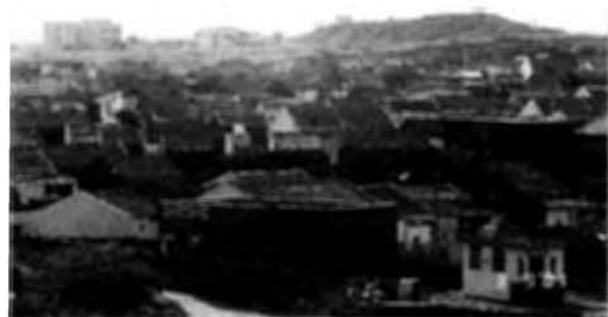
Photo 7.17 Overview of the typical town constituted by low rise masonry structures

Photo 7.17 shows an overview of low masonry structures in the affected area. This

photo depicts the typical town prior to the earthquake.

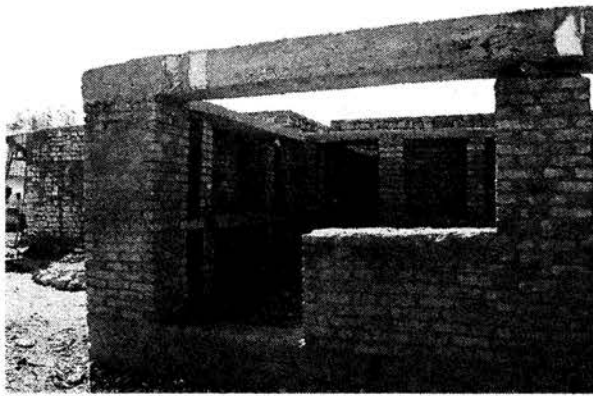
Photo 7.23 Masonry structure with lintel band

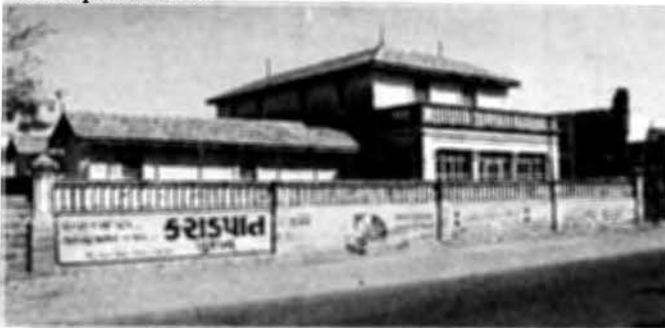
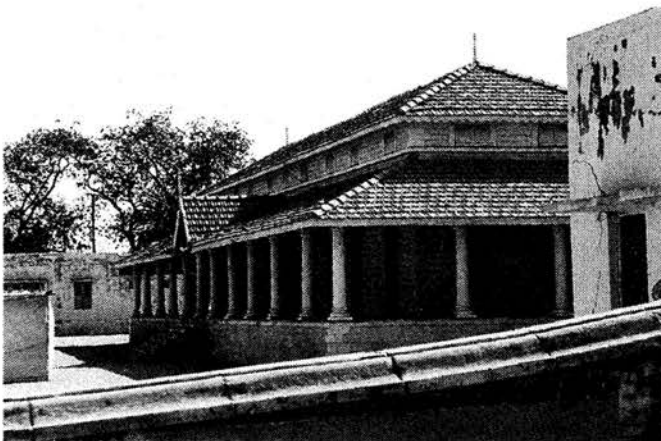
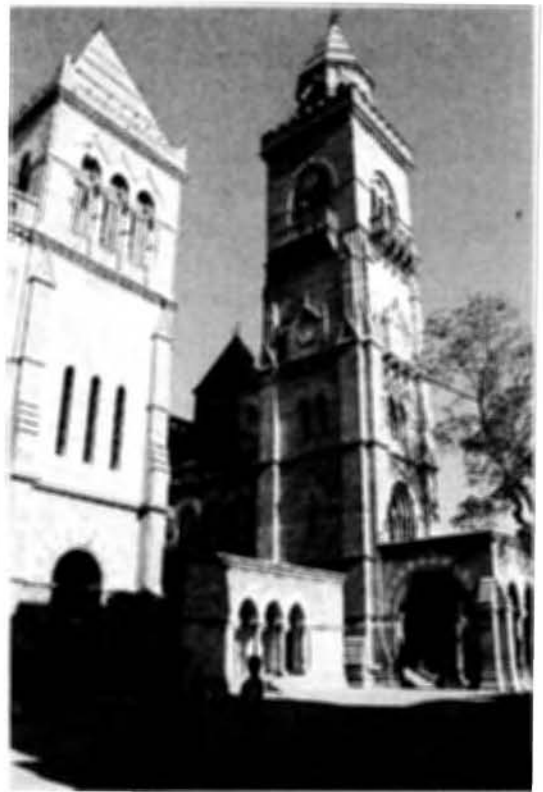
Photo 7.33 Public buildings that did not suffer severe damage during the earthquake. Public structures are enforced by law to follow the seismic design code.

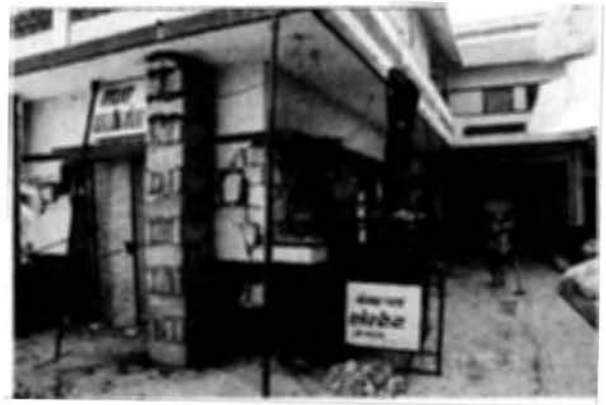
sonry structure G4 shown in Photo 7.38 has a larger natural period than other structures with similar height due to the damage inflicted by the earthquake.

Photo 7.38 Microtemor measurements at a two-story brick masonry house damage level G4

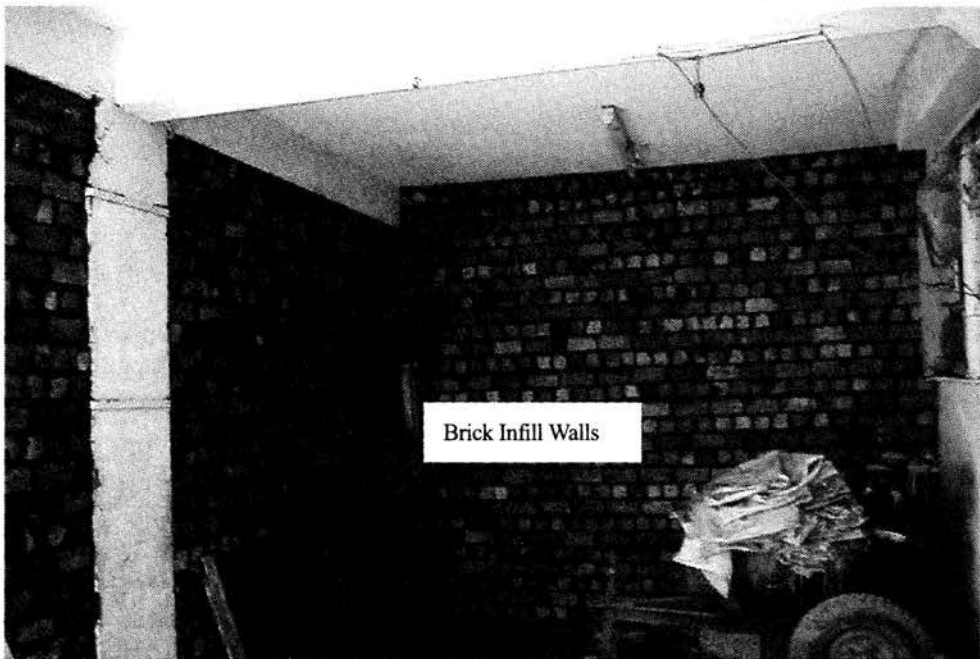
Photo 7.45 is an example of enhancing the lateral loads by the brick infill walls of the open-first story. The anchorage between the brick infill walls and beams and columns was

Photo 7.45 Brick infill walls of the open-first story.
